Client: 15449A Meridian Firs 2

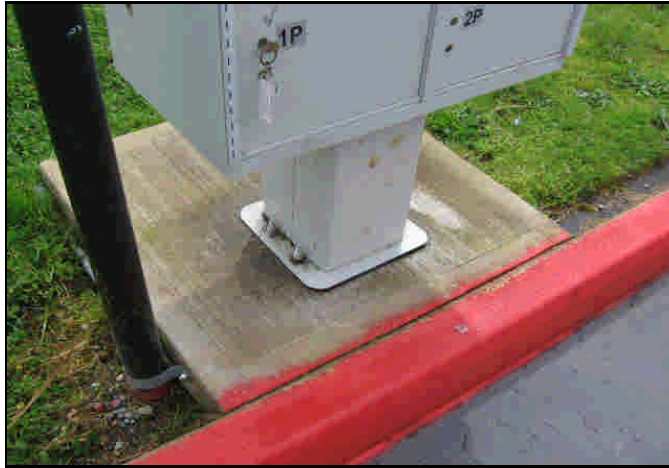
Comp #: 103 Concrete/Curb - Repair/Replace

Evaluation: Fair condition with no significant cracking or damage evident at this time. As routine maintenance, inspect regularly, pressure wash for appearance and repair/replace as needed using general operating funds. Continue to monitor as association ages and if regular patterns of deterioration emerge, funding may be incorporated into future reserve study updates. No basis for reserve funding at this time.

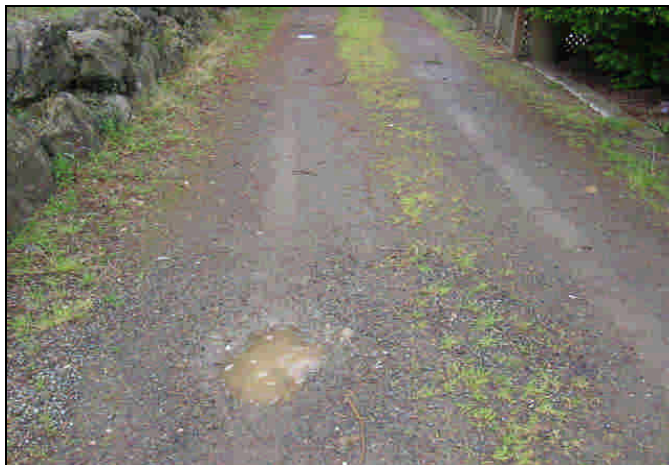
Comp #: 106 Gravel Areas - Refurbish

Evaluation: Generally fair condition, however, areas of thin coverage of gravel apparent. Inspect regularly, control vegetation and fill in any low spots which may develop as needed using operating/maintenance funds. No predictable expectation of significant expense, so no reserve funding suggested. Treat as maintenance item.

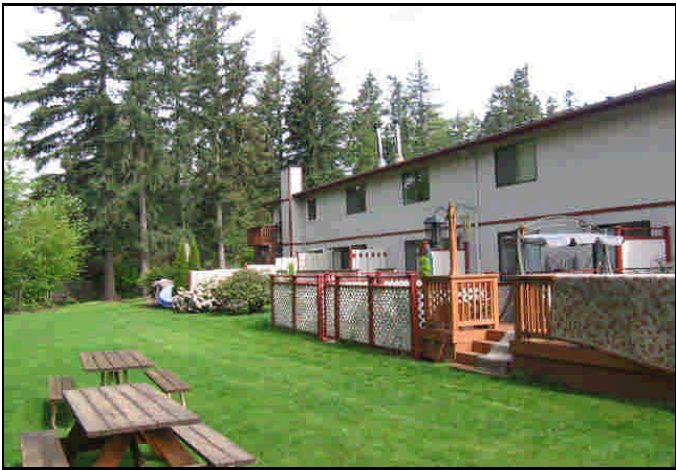
Comp #: 109 **Wood Deck/Rail - Replace**
Quantity: Extensive square feet
Location: Wood decks adjacent to individual units
Evaluation: Varying condition and appearance of assorted constructions. It is our understanding that all decks are the responsibility of individual unit owners to maintain, repair and replace, therefore no reserve funding suggested at this time. In any event, we strongly recommend oversight by the Board to ensure for building waterproofing, deck stability/safety and that a uniform, quality appearance is maintained.

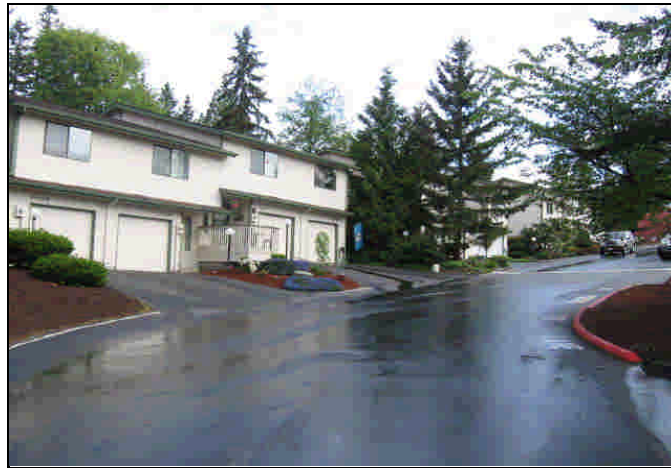
Comp #: 202 Asphalt - Seal/Repair

Evaluation: Generally fair condition with no unusual surface deterioration, fading or widespread damage of asphalt apparent. Reportedly seal coated and repaired last in 2006. Assumed to have been installed over a properly drained and compacted sub-base. Regular cycles of seal coating along with any needed repair has proven to be the best program in our opinion for the long term care of asphalt. Seal coating protects against damaging weather elements while bridging small surface cracks and providing uniform appearance over the inevitable patching and repairs needed over time. Incorporate any restriping and curb repair into this project. Fill cracks and clean oil stains promptly in between cycles. Under this pattern of care there is no anticipation for regular intervals of total remove and replace of asphalt or regular intervals of resurfacing (overlay). We recommend planning for regular intervals of seal coating and repair of all asphalt drives and parking areas for a quality, uniform appearance and protection of surface.

Best Case: \$26,750.00

\$.25/Sq Ft, lower estimate to seal coat, stripe and paint, includes repair allowance

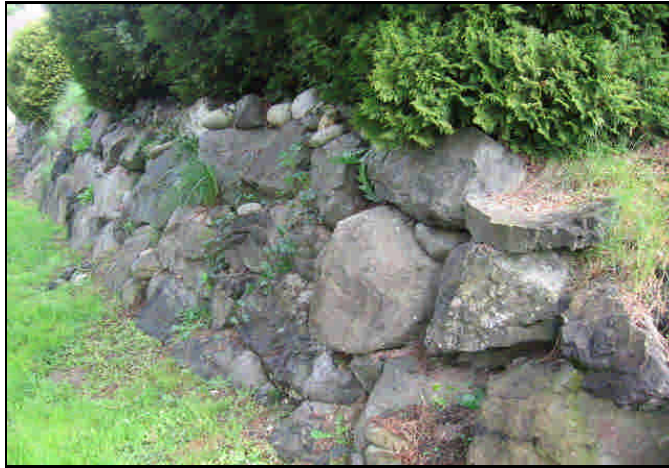
Comp #: 207 Retention Walls - Replace

Evaluation: Fair condition with no significant erosion or instability observed during our limited scope visual inspection. Assumed to have been properly engineered and installed with adequate surrounding drainage. Inspect regularly, repair as needed from operating budget. No expectation of large scale repairs or replacement at this time, no reserve funding recommended.

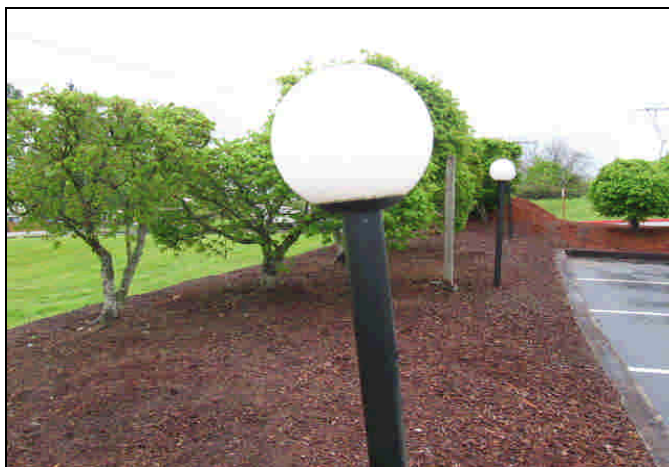
Comp #: 320 Pole Lights - Replace

Evaluation: Good to fair condition with no widespread damage or instability apparent at this time. Observed during daylight hours; assumed to be in functional operating condition. As routine maintenance, inspect, change bulbs and repair as needed from general operating budget. Durable and typically long lived if not abused or damaged, however, best to plan for eventual replacement at roughly the time frame indicated below.

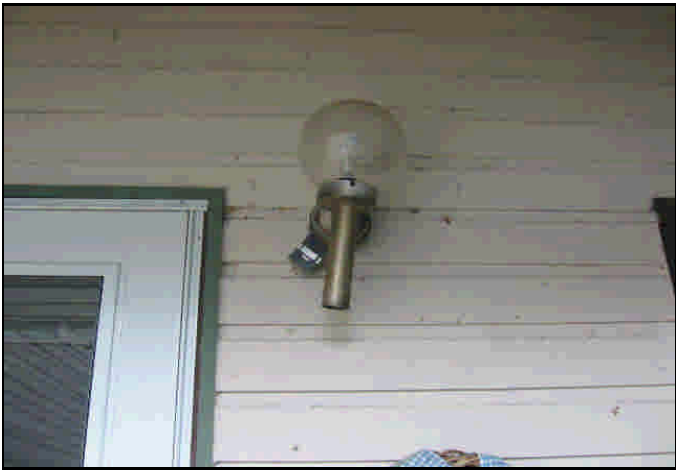
Comp #: 324 Exterior Lights - Replace

Evaluation: No widespread instability, however, residential buildings fixtures appear to be generally older in appearance. Inspect exterior lights at Clubhouse regularly and replace as needed from operating budget. Board contact reports that exterior residential building lights are the responsibility of individual unit owners to maintain, repair and replace, therefore, no reserve funding suggested at this time.

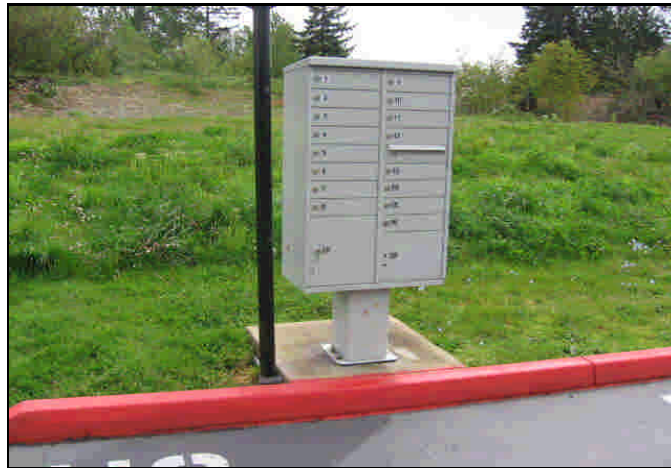
Comp #: 403 Mailboxes - Replace

Evaluation: Good condition and appearance of mailboxes evident. Reportedly replaced last in 2004 at an expense of \$7,500. Inspect regularly, clean by wiping down for appearance, lubricate hinges and repair as needed from operating budget. Best to plan for replacement at roughly the time frame below, due to constant exposure, usage and wear over time.

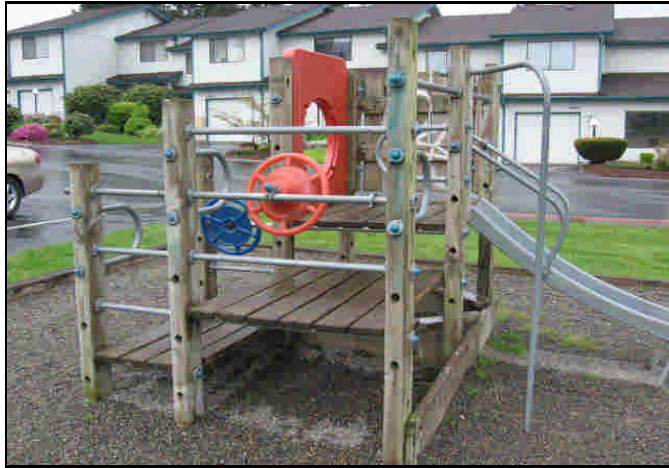
Comp #: 405 Play Equipment - Replace

Evaluation: No significant instability, however, general deterioration noted at this time. Inspect regularly, tighten connections and repair as needed promptly from operating budget as needed. Periodically clean by pressure washing to prevent build up of mold and mildew. Replenish wood chips in fall zones and replace wood borders as needed. Best to plan for regular cycles of replacement, at roughly the interval indicated below.

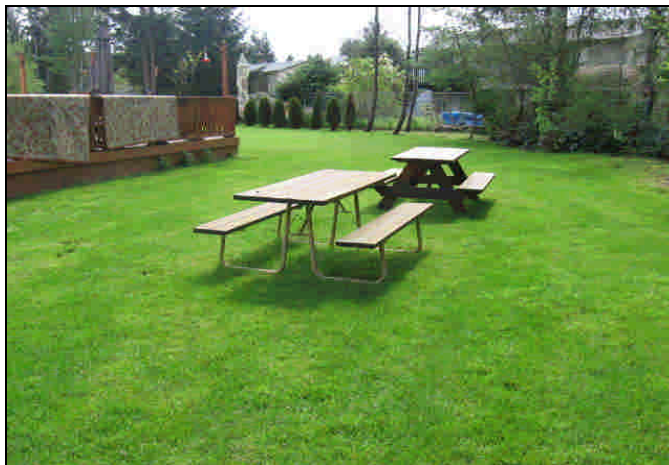
Comp #: 408 Picnic Assets - Replace

Evaluation: Located within common areas, however, reportedly owned by individual Unit owners with individual responsibility to maintain, repair and replace. No reserve funding required at this time, however, we strongly recommend oversight by the Board to ensure for stability/safety and that a uniform, quality appearance is maintained.

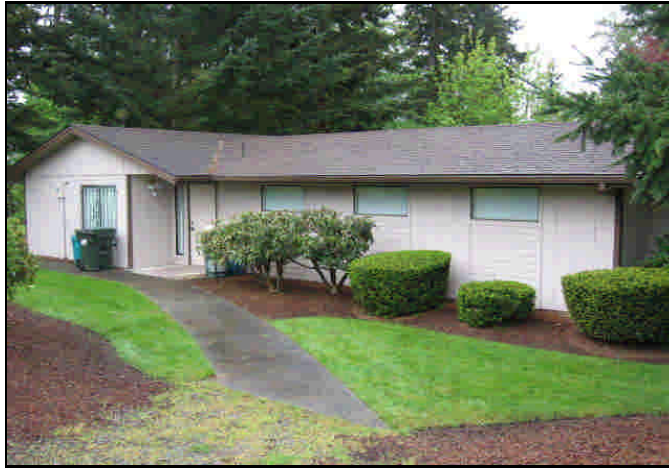
Comp #: 421 Clubhouse Building - Repair

Evaluation: Fair and stable condition with no significant damage observed at this time. It is our understanding that building repairs occurred in 2002 due to fire damage. Inspect regularly, repair promptly as needed from operating budget. Clean, paint and roof along same cycles as other building structures, no need for separate funding. No anticipation of separate cyclical large scale repair needs, therefore no reserve funding recommended.

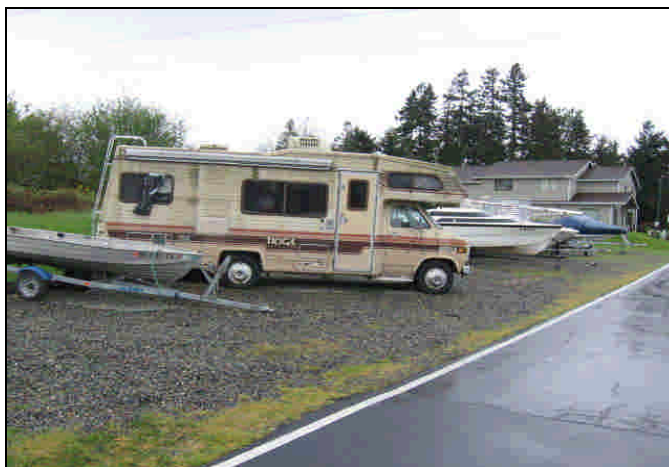
Comp #: 422 R.V. Parking - Refurbish

Evaluation: Simple gravel parking areas only, with no future plans to add improvements such as fencing or asphalt paving as of the time of this reports writing. As routine maintenance, inspect regularly and fill in any low spots which may develop and control vegetation as needed using operating/maintenance funds. No reserve funding suggested at this time.

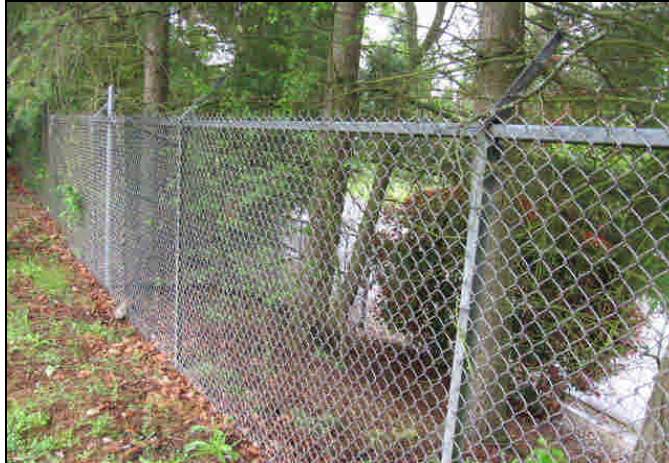
Comp #: 505 Chain Link Fence - Replace

Evaluation: Reportedly the responsibility of the adjacent property owner to maintain, repair and replace, therefore, no reserve funding required.

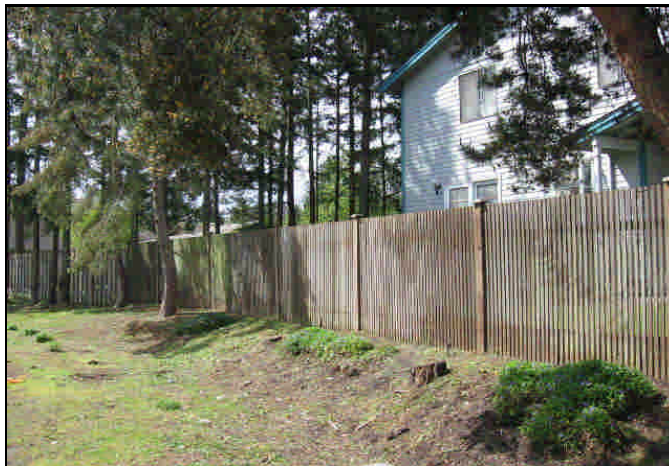
Comp #: 505 Wood Perimeter Fence - Replace

Evaluation: As with chain link fencing, the majority is reportedly the responsibility of adjacent property owners to maintain, repair and replace. Provide maintenance and replacement of small quantity of wood fencing in common area from general operating funds, too small an expense to merit separate reserve designation.

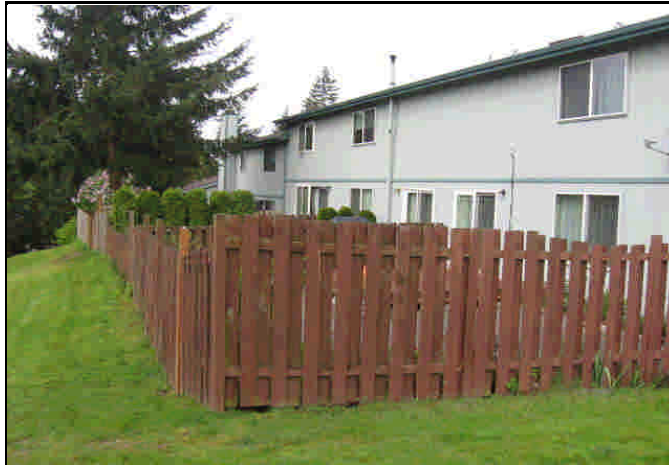
Comp #: 506 Privacy Fence - Replace

Evaluation: Reportedly the responsibility of individual Unit owners to maintain, repair and replace, therefore, no reserve funding required at this time. We strongly recommend oversight by the Board to ensure that a uniform, quality appearance is maintained.

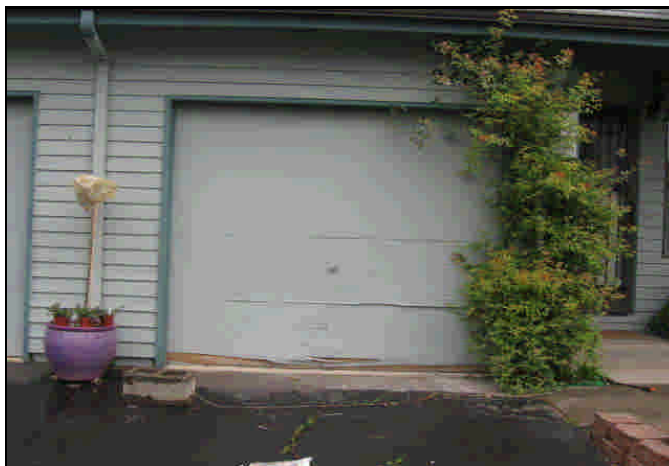
Comp #: 701 Entry/Garage Doors - Replace

Evaluation: It is our understanding that entry and garage doors are the responsibility of individual Unit owners to maintain, repair and replace, therefore no reserve funding required. In any event, we recommend oversight by the Board to ensure that a uniform, quality appearance is maintained.

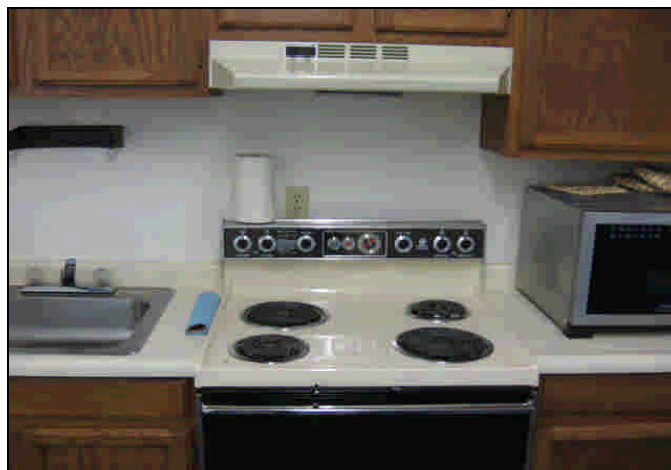
Comp #: 904 Kitchen - Refurbish

Evaluation: Fair condition of appliances and cabinets with no significant damage or deterioration observed at this time. Outdated appearance apparent. Simple, durable materials typically have an extended useful life, however, many communities choose to refurbish the kitchen periodically for aesthetic updating; these may include appliances, kitchen cabinets (reface), sinks, counter tops, etc... Reserve funding suggested at level indicated below.

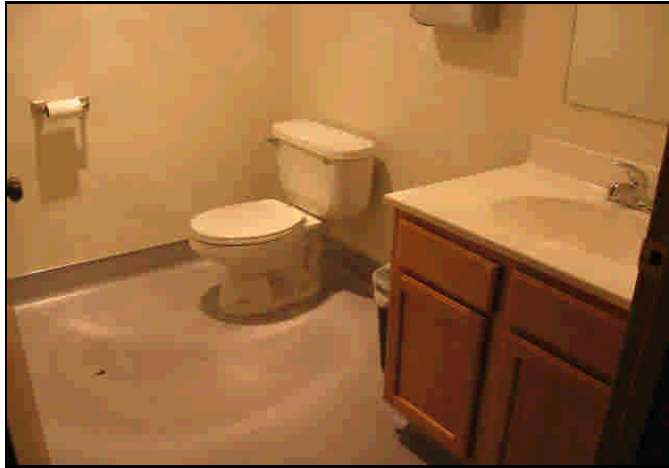
Comp #: 909 Bathrooms - Refurbish

Evaluation: Good condition with no reported problems at this time. Inspect regularly, perform any needed repairs promptly utilizing operating budget. Typically durable components, however, prudent planning suggests setting aside funds for regular intervals of refurbishing which may include items such as vanity, fixtures, fans, wall treatments, etc...

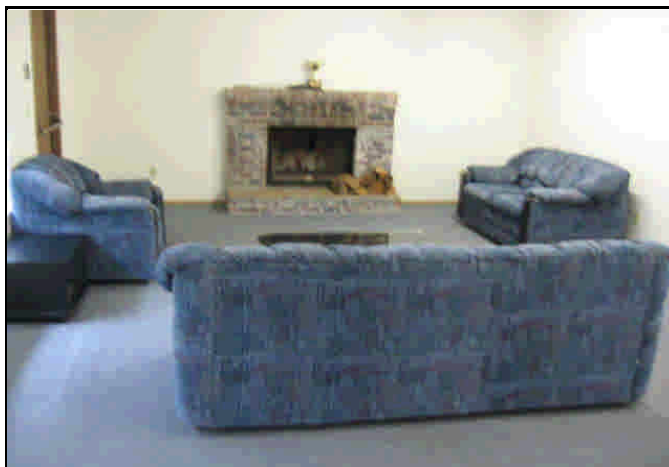
Comp #: 910 Rooms - Remodel

Evaluation: This component suggests setting aside funding for periodic remodeling and aesthetic updating. Many communities replace such items as furniture, wall coverings, lighting, window treatments, artwork, décor, etc... at regular intervals to maintain this important community asset.

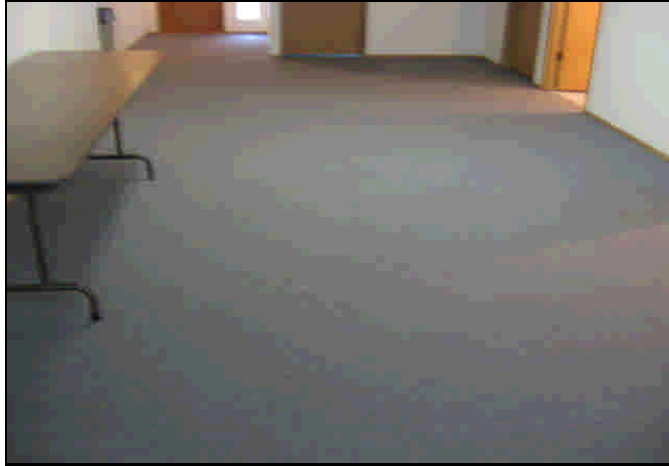
Comp #: 911 Carpet/Vinyl - Replace

Evaluation: Generally fair condition with no unusual staining or wear evident. Carpet and vinyl reportedly replaced last in 2002. As part of ongoing maintenance program, vacuum regularly and professionally clean as needed. Plan for regular intervals of replacement of all flooring, best timed after repainting (component #1110) to maintain a quality appearance.

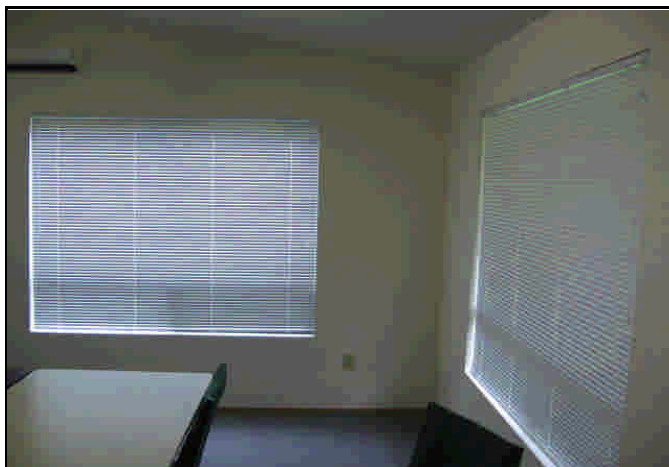
Comp #: 912 Interior Surfaces - Repaint

Evaluation: Fair condition with no significant deterioration or fading apparent. Reportedly painted last in 2002. Regular cycles of paint are recommended to maintain appearance; best timed prior to carpet replacement (component #601). Keep touchup paint on site for in between cycle projects.

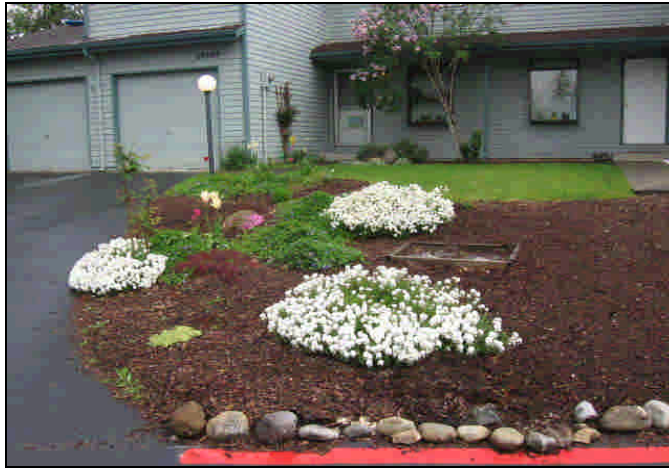
Comp #: 1002 Irrigation System - Repair/Replace

Evaluation: No irrigation identified as Association responsibility. With this understanding, no reserve funding required.

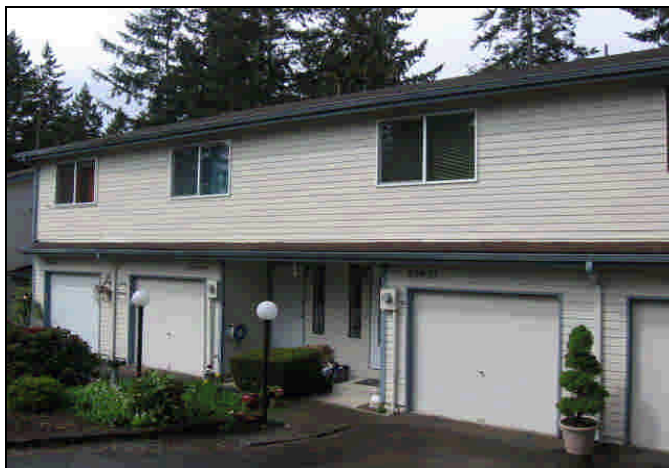
Comp #: 1100 Windows - Replace (a)

Evaluation: It is our understanding that residential building windows are the responsibility of individual Unit owners to maintain, repair and replace. In any event, we strongly recommend the Board provide for inspections and oversight to ensure that the weather proof envelope and a consistent, uniform appearance of the buildings is ensured.

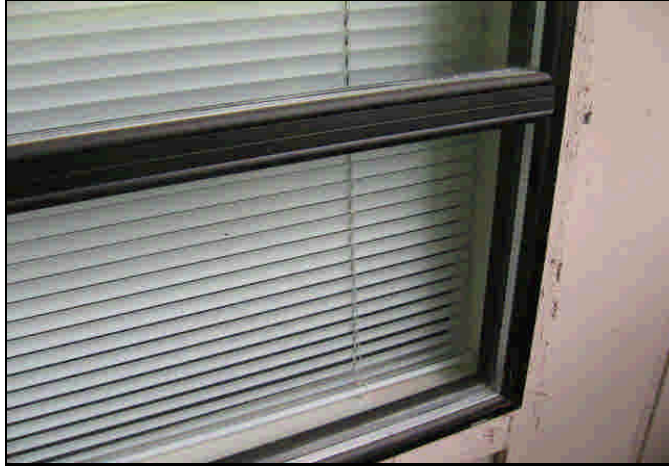
Comp #: 1 100 Windows - Replace (b)

Evaluation: Fair condition of recreation building windows with no unusual deterioration apparent. Several windows replaced in recent past, no reported problems. We strongly recommend regular professional inspections and prompt repair/replacement as needed to ensure building waterproofing and help prevent structural damage. If properly installed without defect, windows are typically durable and have an extended useful life. No reserve funding recommended, treat as maintenance item at this time.

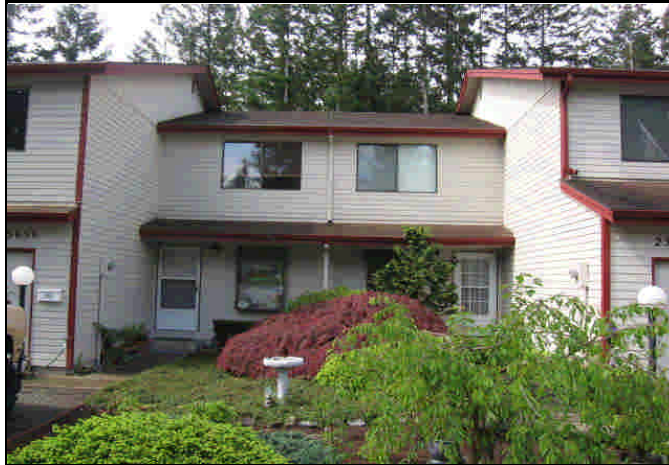
Comp #: 1116 Exterior Surfaces-Clean/Seal/Paint

Evaluation: Varying appearance and condition observed during our limited scope visual inspection, with local deterioration and fading evident. It is our understanding that the community has a history of \$12,000 in painting expenses annually, arriving at completion of all building structures in (7) years. We strongly recommend regular professional inspections with prompt repair as needed to ensure that the water proof integrity of the buildings is maintained. Typical Northwest paint cycles are between five and eight years depending upon surface preparation, material quality, application methods, site and weather conditions. Removal and replacement of caulking with high quality product is important part of surface preparation. Repair any siding necessary prior to painting. As your pattern of exterior painting is well established, plan to continue phased cleaning, sealing and painting at the interval below.

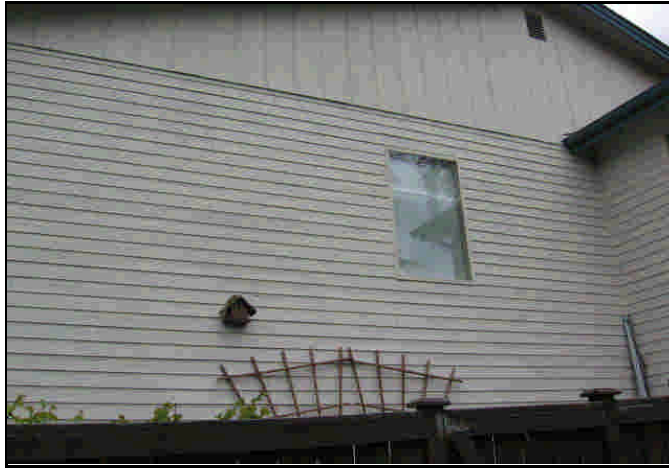
Comp #: 1121 Exterior Siding - Replace

Evaluation: Generally fair condition, however, local areas of deterioration observed during our limited scope visual inspection. Board contact indicates that siding repairs are considered the responsibility of the Association for purposes of long term planning. We recommend regular professional inspections with prompt repair as needed to ensure weather tightness of buildings is maintained. Durable, long lived product assuming proper care and maintenance. No anticipation of total replacement within the scope of this study, however, as the community continues to age, we suggest a general funding allowance for local spot repair/replacement, timed to coincide with paint projects. Adjust as conditions dictate in future reserve study updates.

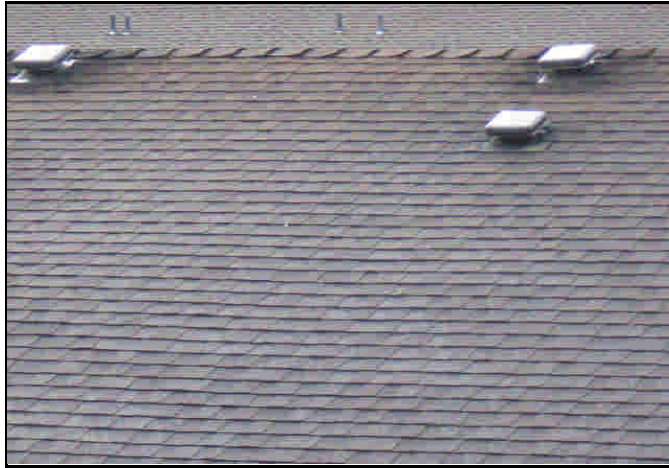
Comp #: 1303 **Comp Shingle Roof - Replace**

Evaluation: Generally fair condition with no widespread damage or missing shingles observed during our limited scope visual inspection. Original wood shake roof reportedly transitioned to existing compositional shingle in 2001 at an expense of \$325,000. We strongly recommend professional inspections at least twice annually and after wind storms, promptly replacing damaged/missing shingles or any other repair as may be needed to ensure that the water proof integrity of the buildings is maintained. Keep gutters and downspouts clear and free of debris to allow water to evacuate from rooftops as designed. Assuming ordinary care and maintenance, plan for replacement at roughly the time frame indicated below.

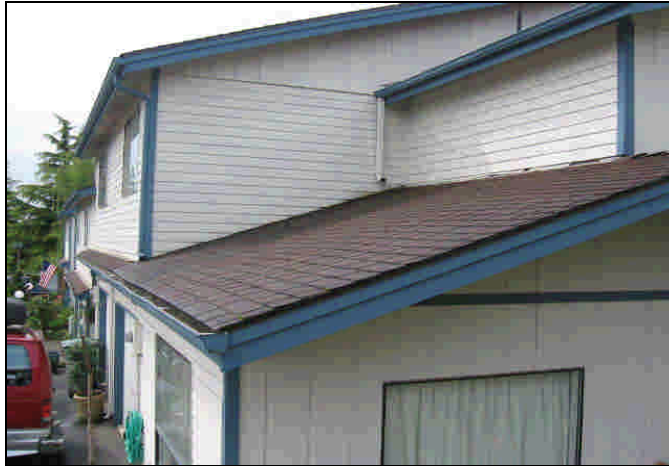
Comp #: 1310 Gutters/Downspouts - Repair/Replace

Evaluation: Generally fair condition with no significant damage or instability observed at this time. It is our understanding that the gutters and downspouts are considered part of the roof for purposes of long term planning. Inspect regularly, keep gutters and downspouts free of debris to ensure water evacuating from rooftops as designed and repair as needed from general operating funds. Best to plan for total replacement, at the same interval as roof replacement, for cost efficiency.

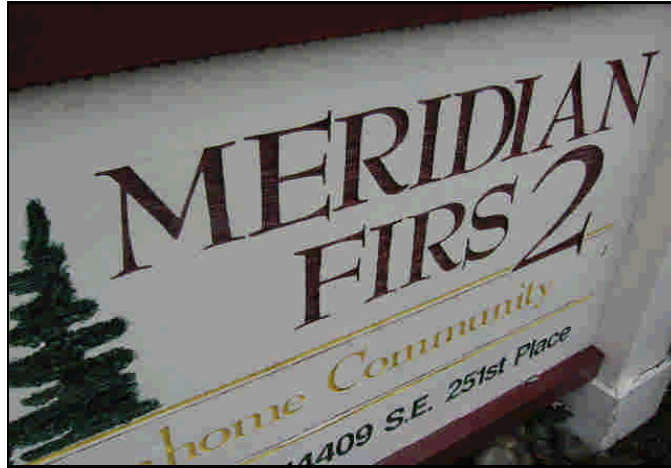
Comp #: 1402 Entry Signs - Replace

Evaluation: Fair structural condition of entry sign with no significant cracking , damage or instability of wood surfaces observed at this time. Inspect regularly, clean for appearance, paint and repair from operating budget. With ordinary care and maintenance, we suggest planning for regular intervals of replacement to maintain a quality appearance at roughly the time frame indicated below.

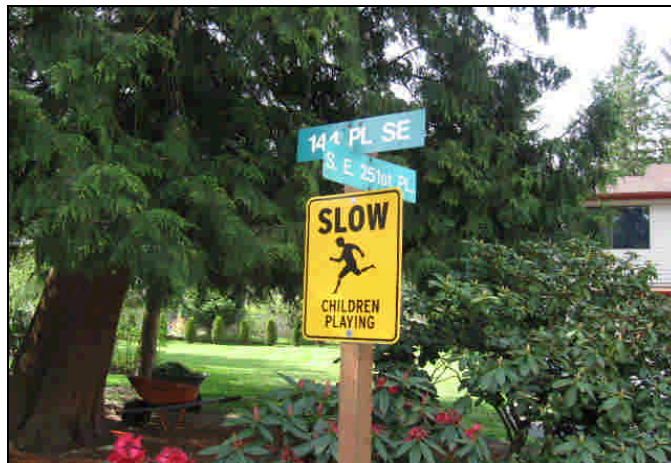
Comp #: 1415 Required Signage - Replace

Evaluation: Fair condition of assorted signs with no significant damage, deterioration or instability observed at this time. Inspect regularly, clean for appearance, repair and replace from operating budget. Too small an expense for reserve designation, treat as maintenance item.

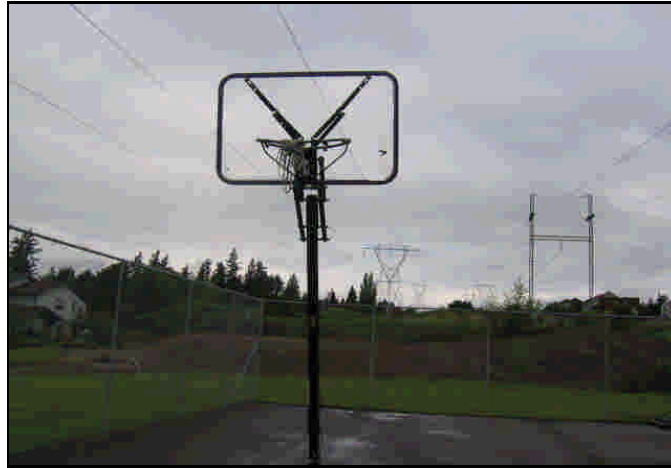
Comp #: 1608 Basketball Equipment - Replace

Evaluation: Fair to poor condition of assorted moveable assemblies, with deterioration evident at this time. Located within common area, however, reportedly owned by individual Unit owners with individual responsibility to maintain, repair and replace. No reserve funding required at this time, however, we strongly recommend oversight by the Board to ensure for stability/safety and that a uniform, quality appearance is maintained.

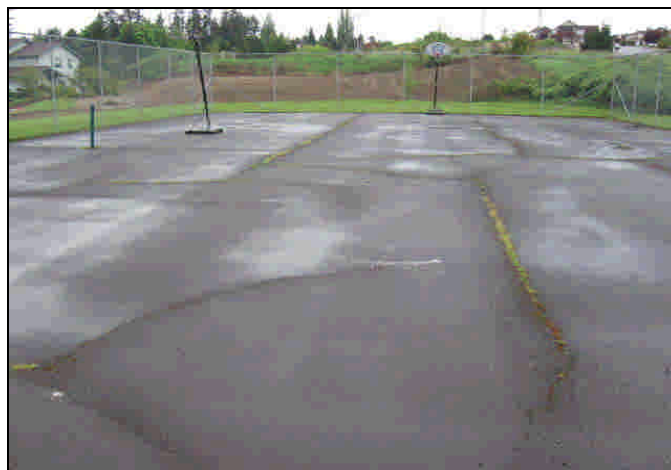
Comp #: 1609 Tennis Court - Repair/Resurface

Evaluation: Poor, unplayable condition with cracking, damage and instability observed at this time. Inspect regularly, fill/seal any cracks which may develop to prevent further damage, paint and repair to maintain functionality and appearance. No preliminary bids for repair, a general funding allowance to refurbish recommended at the level indicated below.

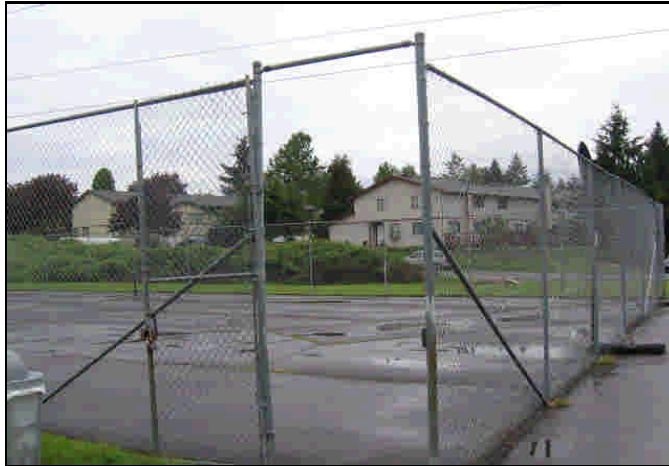
Comp #: 1610 Tennis Court Fencing - Replace

Evaluation: No widespread instability, however, poor appearance with general deterioration and local areas of damage and corrosion observed at this time. Inspect, clean and treat for corrosion; repair promptly as needed from operating funds. Typically a sturdy component that can last for extended period of time if not damaged or abused. Best to plan for regular intervals of total replacement at the interval indicated below.

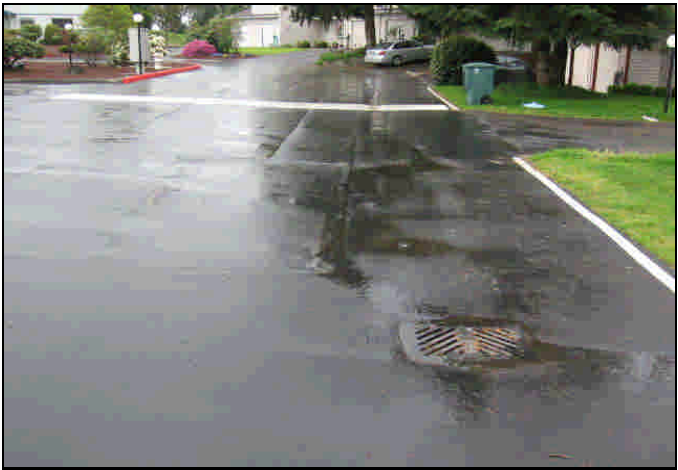
- Comp #:** 1807 **Drainage/Storm System - Replace**
Quantity: Extensive systems
Location: Throughout community
Evaluation: No significant problems reported within common areas at this time. Assumed to have been generally designed with adequate provisions for community drainage needs. Inspect regularly, keep drains and grates free of debris and free flowing to ensure water evacuating as designed. Pump out sediments when needed utilizing mobile evacuator service; fund from operating budget. No expectation of large scale cyclical repairs/replacement at this time. No reserve funding recommended.

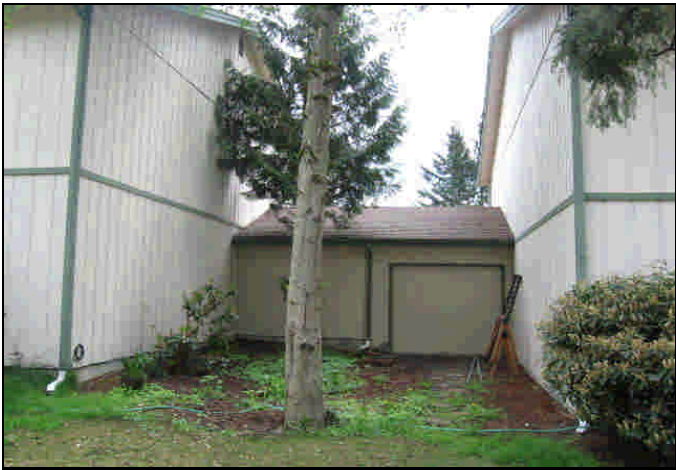
Evaluation: This component may be utilized for larger tree removal/trimming projects which do not occur on an annual basis. If the community has not already done so, consult with a qualified arborist for a long term plan for the care and management of the trees within the community, balancing aesthetics with protection of association assets. Tree removal/trimming expenses currently handled thru the operating budget, incorporate into future reserve study updates if conditions merit.

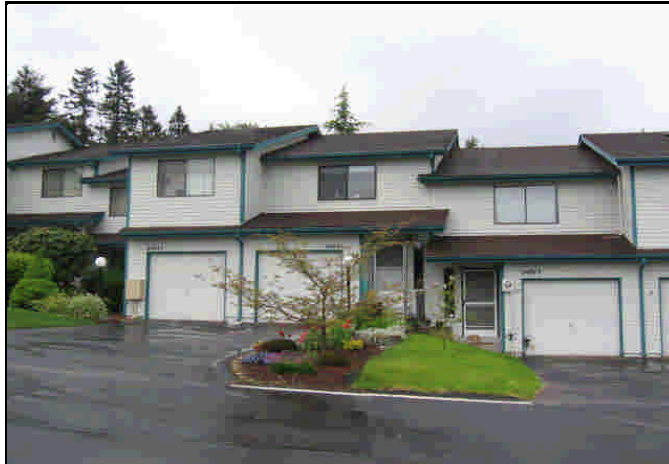
Comp #: 1811 Plumbing - Repair/Replace

Evaluation: It is our understanding that residential building plumbing is the responsibility of individual unit owners to maintain, repair and replace, so no reserve funding suggested for such at this time. No reported problems with common area plumbing (including recreation building). Assessing the plumbing systems is beyond the scope of a reserve study. If installed per architectural specifications and local building codes, there is no predictable time frame for large scale repair/replacement expenses within the scope of our report. Treat minor repairs as ongoing maintenance expense. Funding may be incorporated into future reserve study updates if conditions change.

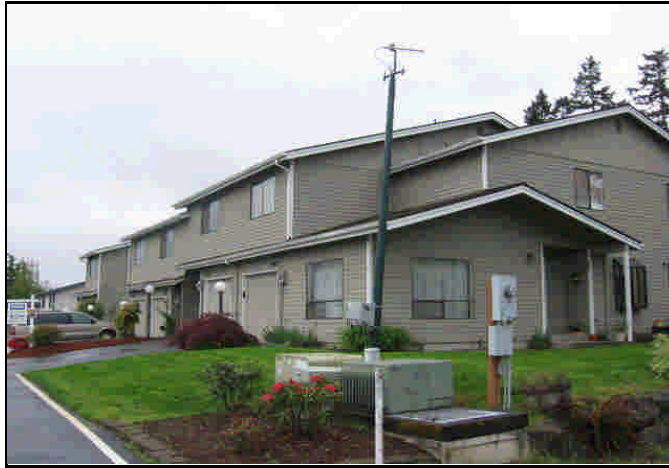
Comp #: 1812 Electrical - Repair/Replace

Evaluation: Assessing the electrical systems is beyond the scope of our services. Board contact reports that residential building electrical systems are the responsibility of individual unit owners to maintain, repair and replace, therefore, no impact on reserves factored for these systems at this time. No reported problems with common area electrical systems and if installed per architectural specifications/local building codes, there is no predictable time frame for large scale repair/replacement expenses within the scope of our report. Treat minor repairs as ongoing maintenance expense. Funding may be incorporated into future reserve study updates if conditions change. No reserve funding suggested at this time.
