Ongoing Repairs of the Winterhaven Street Leak

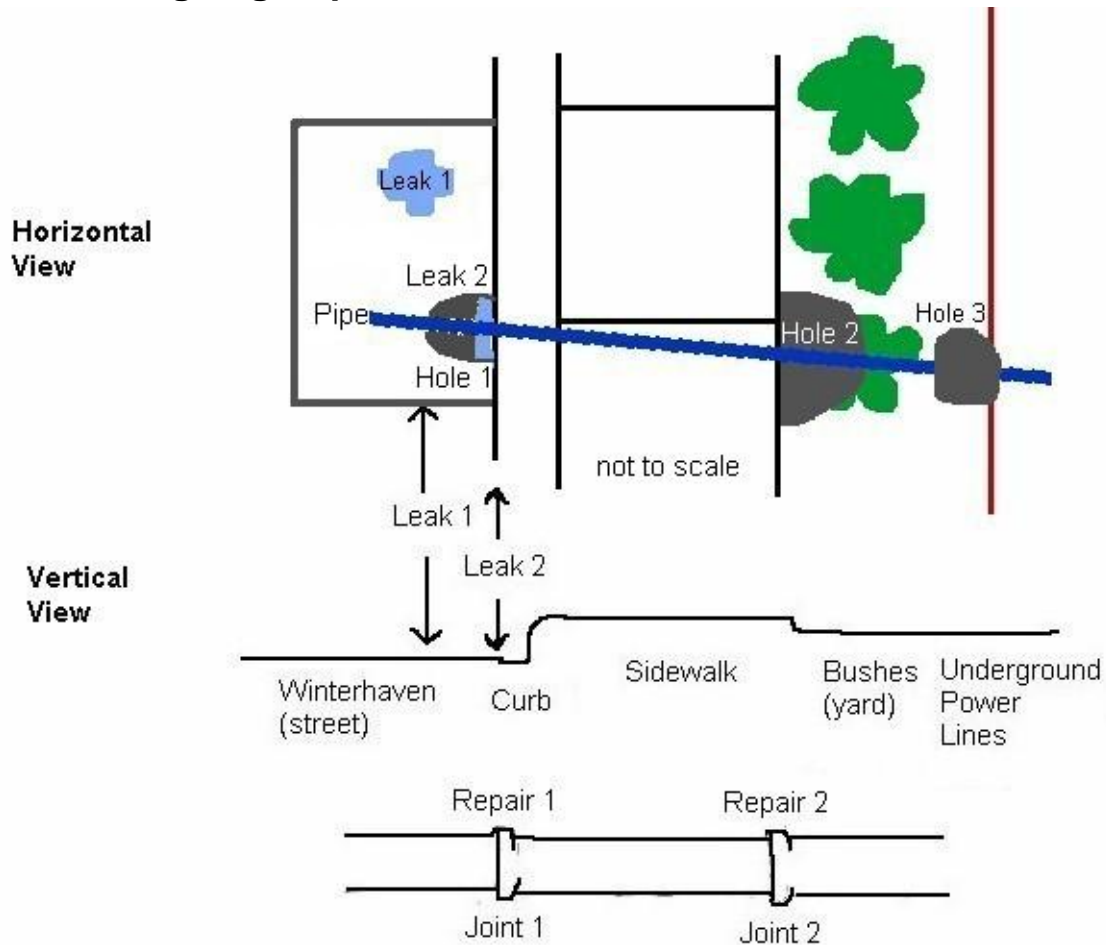
homeowner and us traced the pipe into his yard and began to dig. The top of the pipe is about 32 inches underground. We tunneled under the sidewalk and uncovered Joint 2 (Hole 2 in diagram). The area was monitored during the next irrigation, but the Hole 2 filled with water before the origin of Leak 1 and Leak 2 could be determined. We tunneled deeper and exposed more of Joint 2. RWCD gave us 1 hour of water prior to the November 25, 2007 irrigation. All of this water was directed into the lateral. A significant amount of water shot out gaps in both sides of Joint 2. A few minutes later, Leak 1 and Leak 2 appeared in Winterhaven. No leakage water showed up in the Underground Power Line area (Hole 3 in diagram).

Both Joint 1 and Joint 2 had large gaps without an O-Ring in place. The contractor said that it looked like the pipe had not been put in properly. Most likely Joint 1 and Joint 2 were both leaking. After the gap in Joint 1 was filled, the Joint 2 leakage water could not get through the sidewalk and flowed under it. The water surfaced at the easiest place which was at the border between the curb and street (Leak 2) which just happened to be immediately above Joint 1. This may also account for Leak 1 which is off to the side and not directly above any pipes. The gap in Joint 2 was filled by the same contractor on December 5. Hole 2 was left open for monitoring during the last irrigation before dry up.
