RTC-TH Jun 2011 Special Update

Fire on the Farm

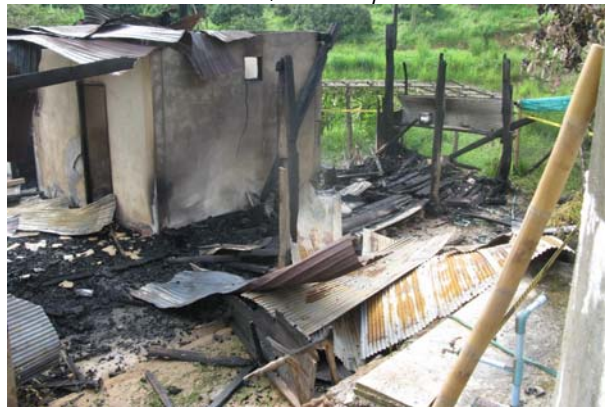
The brick walls of the bathroom and the outdoor kitchen

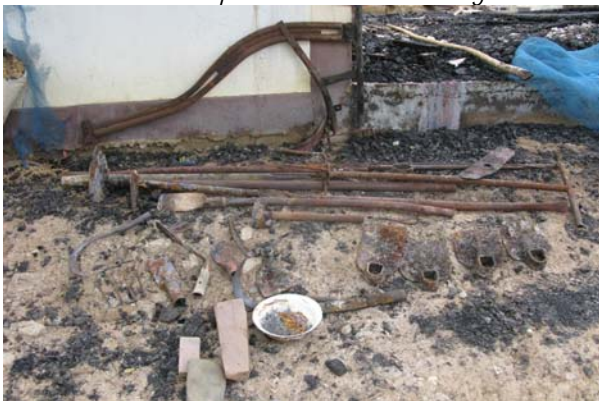
Hand tools salvaged from the fire.

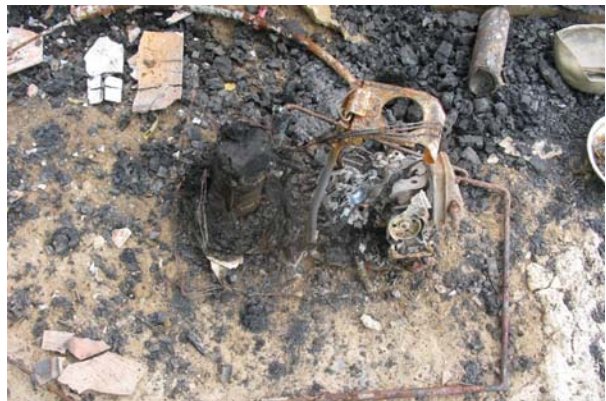
Power tools that didn't make it.

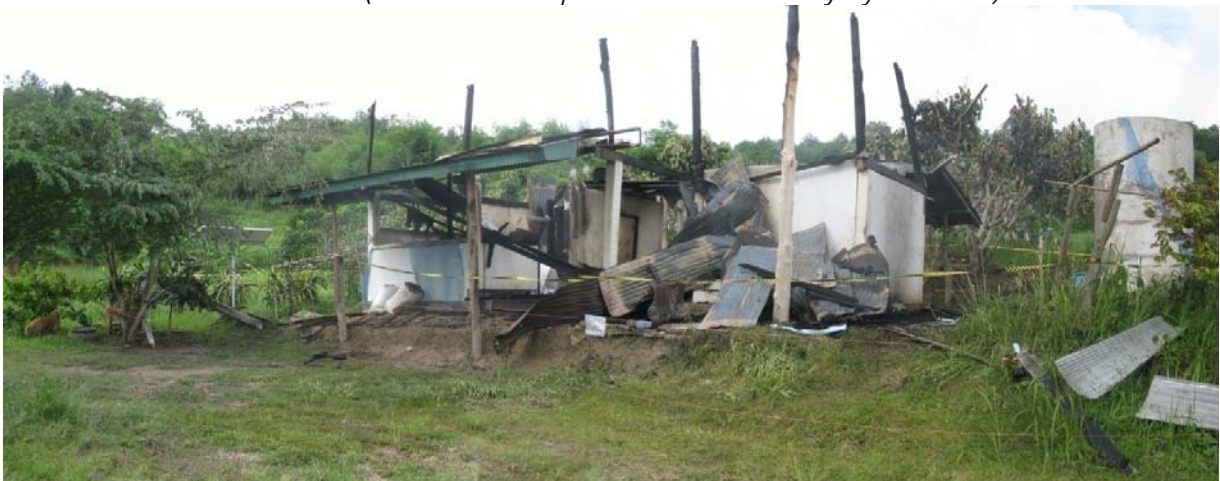
Remnants of the green porch awning remain. (Note the solar PV panel at left marked by a yellow arrow)

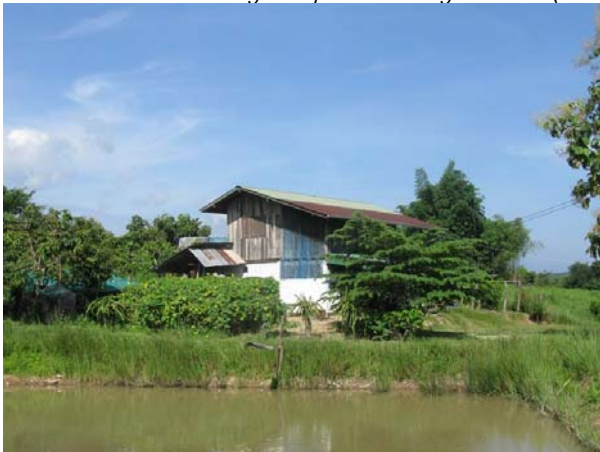
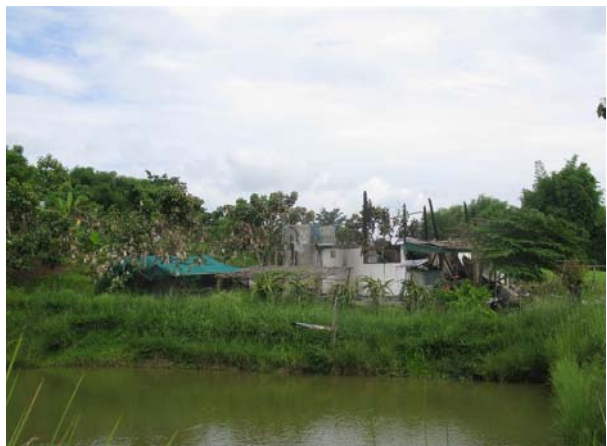
A before and after photo set from across the West Fish Pond. Notice the radiant heat damage to the orchard.

The radiant heat damage to nearby plants was more extensive in the orchard at the rear of the farmhouse. This suggests the fire was more intense there; the wind was blowing in that direction, or both.

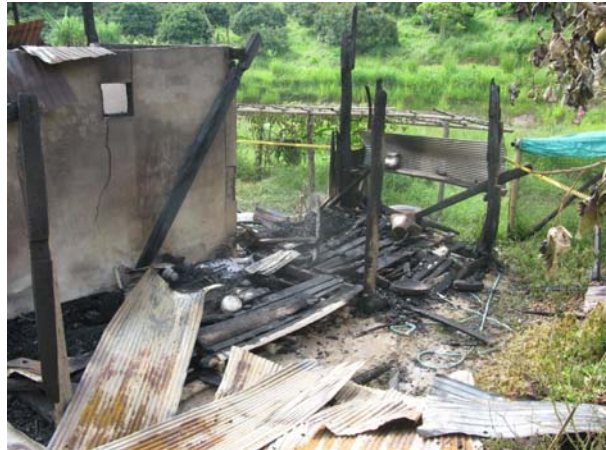
One shelf with a pot remains in the outdoor kitchen

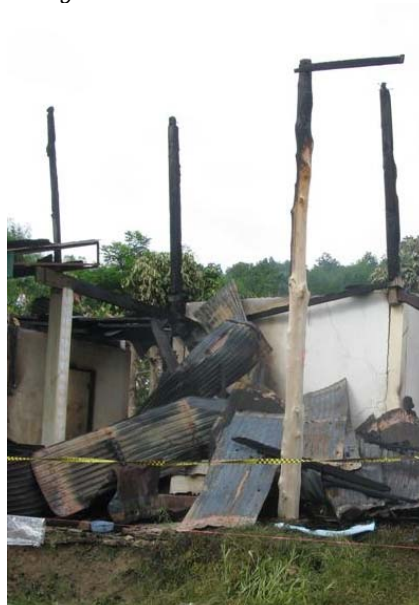
After the fire, porch covered with fallen roofing; stairs were burned away.

The front porch is covered with scorched sheet metal roofing panels. The stairs are gone and the entire second floor. Only a few charred vertical posts remain.

The concrete pillars and brick walls on the ground level are still standing, but their structural integrity is questionable after being subjected to

the heat of the fire. The basic post and lintel design means the walls are non-load bearing. The posts and lintels carry the structural load.

Plans to rebuild won't be implemented until the dry season in Nov. The sala on the East fish pond and the old Pig Shed are viable shade structures. The only restroom was at the farm house. If the toilet and septic tank plumbing were not damaged or destroyed by the fire, a temporary shelter roof over the old toilet could put it back into operation once the water supply line from the nearby water tanks is replaced.

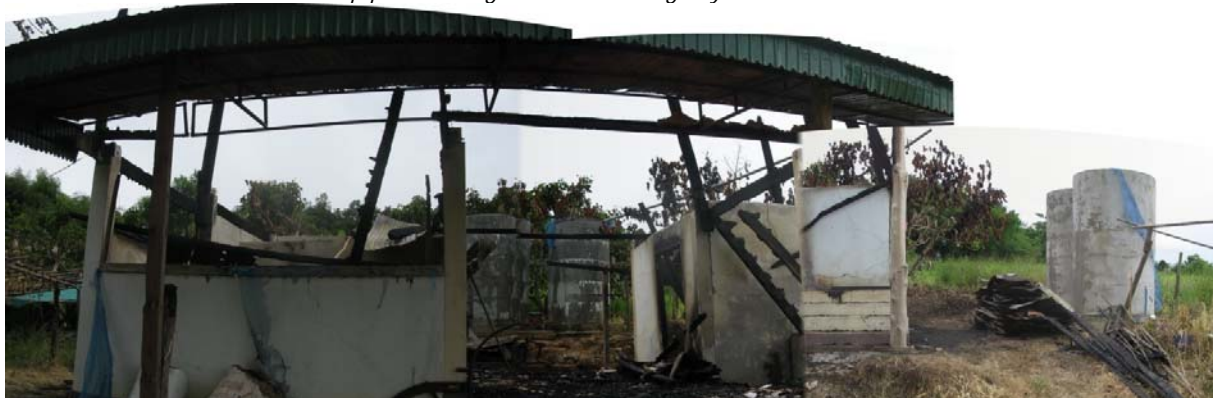
End of the first day of clean up has most of the fallen sheet metal roofing removed from the house.

There appears to be heat damage to the upper portions of some of the concrete pillars. The second floor wood pillars were bolted to the tops of the concrete pillars. The weight of the collapsing structure causes some fragmentation of the concrete pillars at the locations of the steel bolts. Part of the back wall of the tool room collapsed, and large cracks are in 2 of the bathroom walls. We couldn't assess the kitchen as we haven't been able to remove the fallen debris fill half of the room.

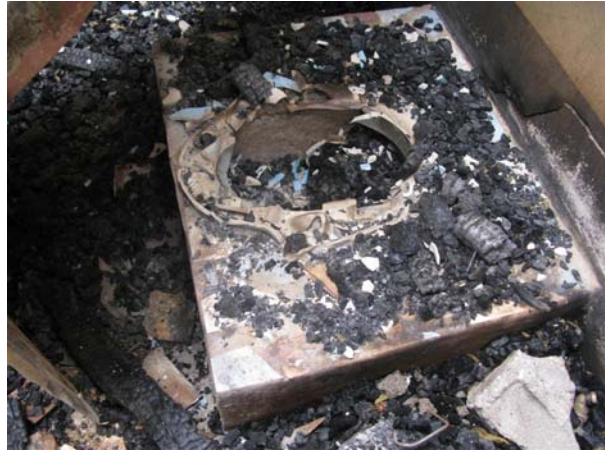
The fire's heat fragmented the ceramic squat toilet bowl

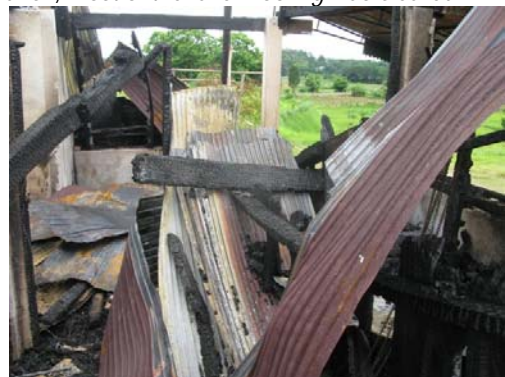
The debris filled kitchen.

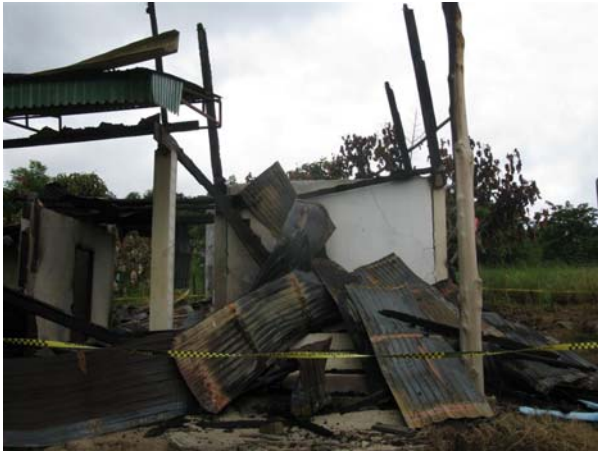
Debris cleared from the front porch. Only the charred stair stringers remained without any steps.

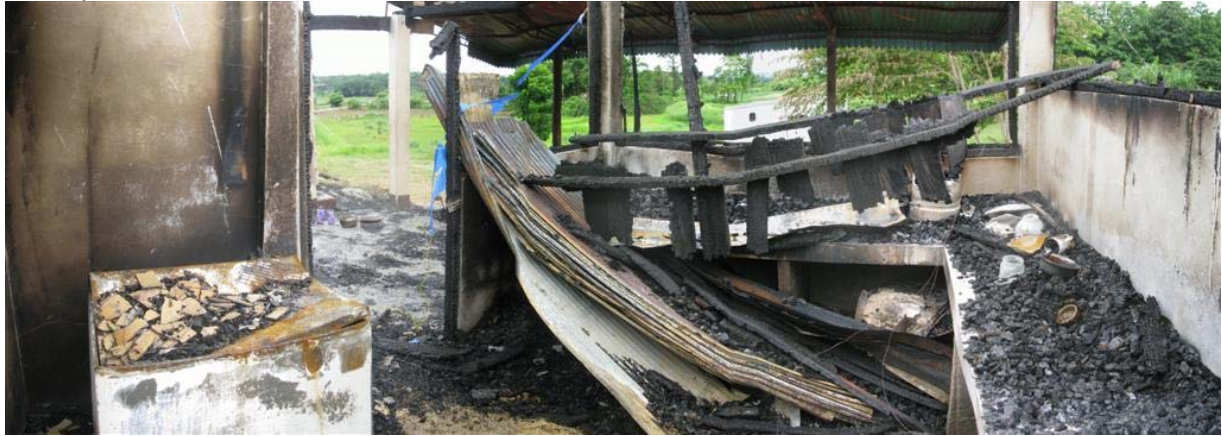
Day 3 of the clean up set goals to clear the space under the stair well and remove the major debris from the kitchen. Charred joists from the upper floor and some salvaged roofing sheet metal were stored upstairs all fell into the kitchen area. The front part of the

The kitchen at the start of Day 3 of the clean up.

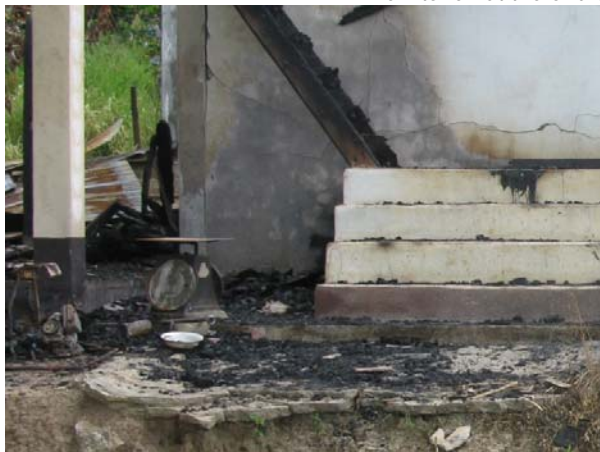
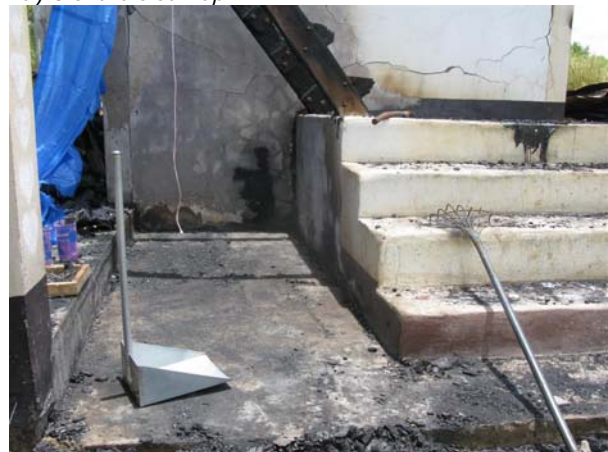
The area under the stairs had a small wood storage cabinet. Nothing remained after the fire.

Melted plastic and “crackled” glass were notable differences in the charcoal found in the kitchen and the under stairs areas. The plastic had to be scrapped off the floor and came loose in dinner plate sized patches. Glass bottles held their shape by the glass

but was “artistically” crackled. They were fragile and easily crumbled when handled.

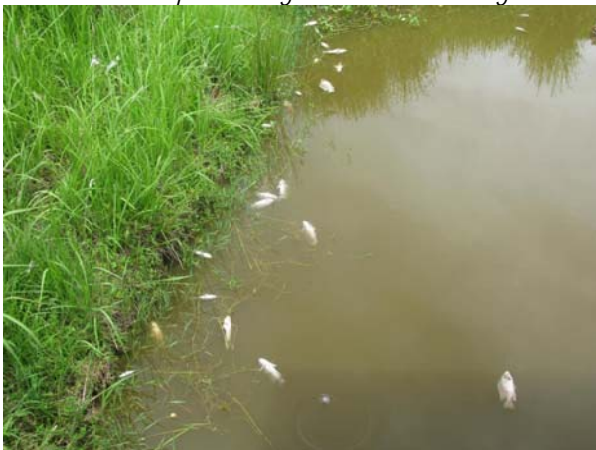
Fish die off due to lack of dissolved oxygen

The week loss of electric power meant we could not aerate the fish ponds. The East Pond was particularly affected, and fish began to die from lack of oxygen. The recent cloudy weather and algae problems. The Agriculture Department and the Fisheries Department acted quickly and sent a representative to assess the situation and offer advice and assistance. Some compensation is available, and we will use the dead fish to make EM (effective micro-organisms) to mix with our soil and compost. The Agriculture Department is providing the EM starter packets. So as unlikely as it seems, the fire affected the “water” adding yet another clean up activity to the “to do” list for fire clean up.
