Update "With-Site-Visit" Reserve Study

Meridian Firs II Kent, WA

Report #: 15449-1

Date Prepared: February 18, 2013

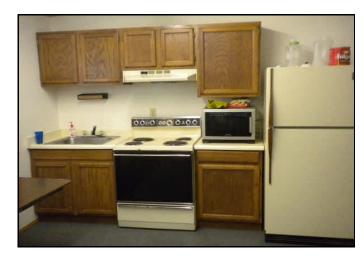
and lower cabinets. Area appears in overall good condition, but dated, with no significant damage or

deterioration observed at this time. Anticipate refurbishment due to age and to maintain the appearance of the
