JKK Job Number: 1.07.0258001

1.0 INTRODUCTION

Jason K. Kelley, PE, has been contracted by Moon Mountain Vistas HOA (HOA) to provide a drainage evaluation for the Moon Mountain Vistas Unit III community (community). The purpose of this report is to present prioritized solutions for mitigating debris and sediment issues.

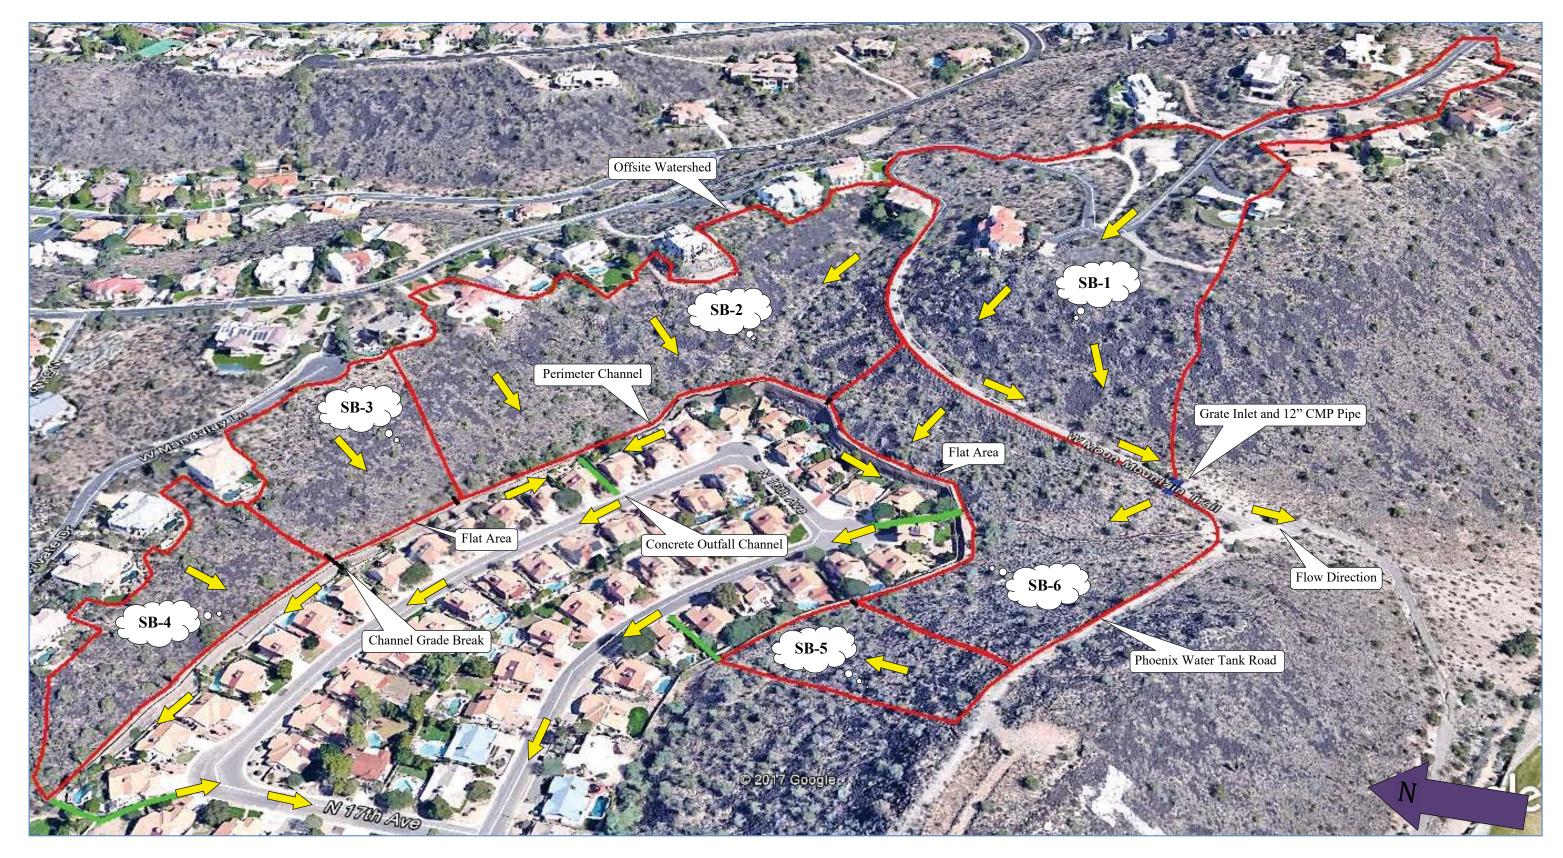
Figure 1 – Drainage Map

Areas of the hillside drain to specific portions of the perimeter channel. Figure 1 labels the approximate sub-areas contributing stormwater runoff to the channel (SB-1 through SB-6). The channel was constructed with highpoints (grade-breaks – black lines on Figure 1) from which it slopes in opposite directions eventually leading to the outfall channels (green lines). The highpoints and outfall channel locations are identified in Figure 1. There are two portions of the channel that are relatively flat (see Figure 1 and Photo 6). Flow directions (yellow arrows), the grate and pipe culvert locations (blue lines) are shown on Figure 1 as well.

(1) Deposition (accumulation) of sediment will continue to occur in flatter areas of the perimeter channel and ongoing maintenance will be required to clean sediment build-up after storms (see Figure 1 for location of flat areas).

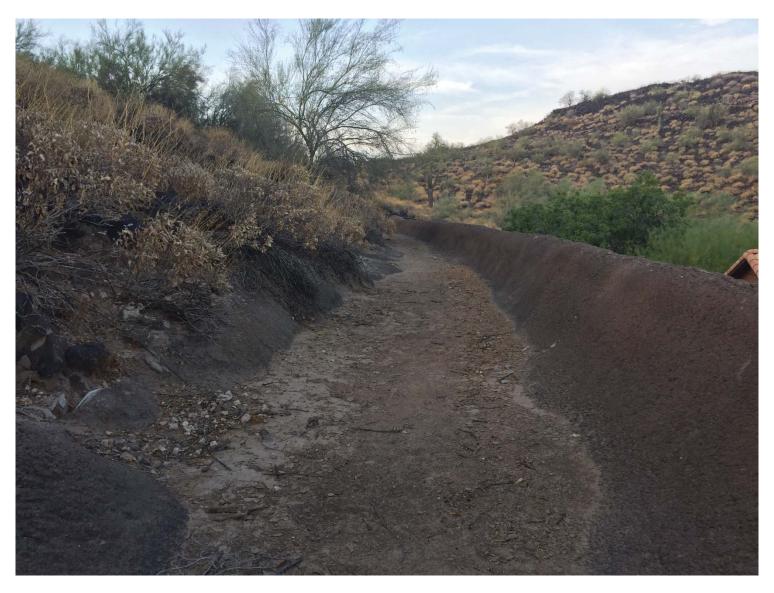
Photo 6 – Sediment Accumulation in Flat Portions of the Perimeter Channel

- (1) Clean sediment build-up after storms.
- (2) Steepen slope in perimeter channel by removal and construction. Advantages: Eliminates ponding and sediment buildup. Disadvantages: Major construction, structural engineering efforts and associated design and construction costs would be required to remove and adjust the perimeter channel and top of the retaining wall. Excavation of the hillside and addition of retaining wall against the hillside would be required.

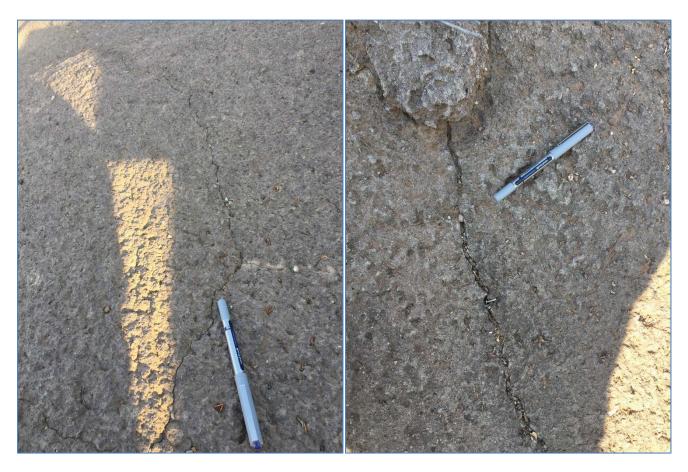
Minor cracking was observed in various locations. Temperature expansion/contraction cracking is normal for soil cement and most cracks are 1-2 mm in width (see Photo 7).

Photo 7 – Minor Cracking of Perimeter Channel

(1) Apply concrete grout to cracks (see Photo 7). Brush any debris and pebbles out of cracks and hand apply grout into crack and on surface along crack. Advantages: Low cost, hand application. Disadvantages: None.

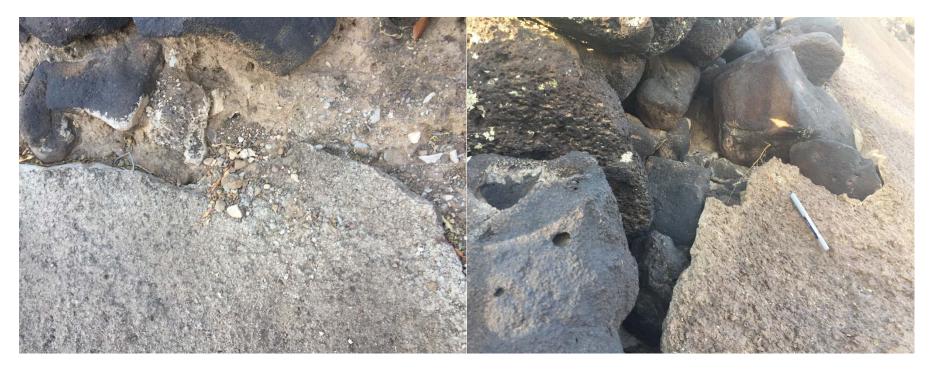
Minor exposure and scour was observed in various locations along the grouted edge against the hillslope. This is attributed to removal of sediment during rain storms and settlement over time (see Photo 8).

Photo 8 – Grouted Edge Exposure

(1) Apply concrete grout at edges of perimeter channel against hillslope. Advantages: Will limit seepage under edges of perimeter channel. Low material cost, hand application (see Photo 8). Disadvantages: Application of larger amounts of grout, access of equipment to perimeter channel. Higher labor costs than crack grouting.

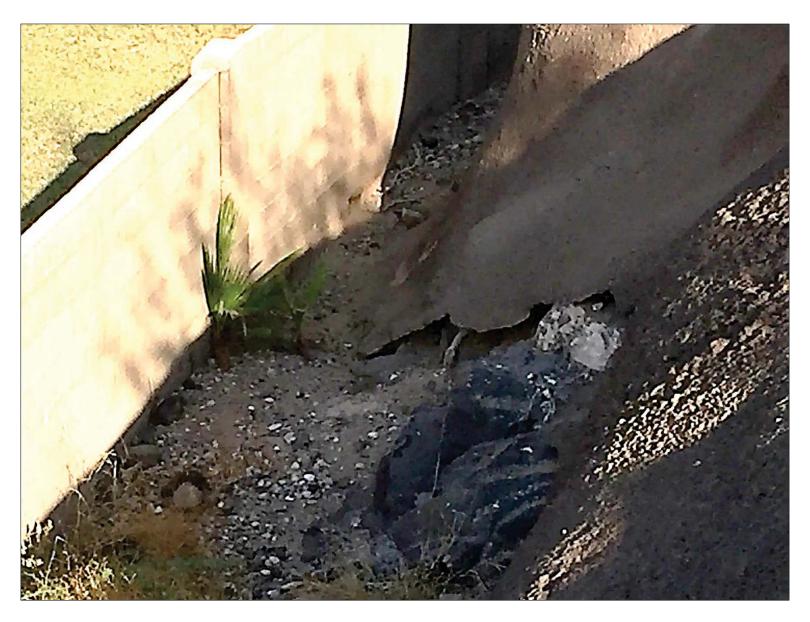
General comment regarding item (2): Observed exposure at the bottom of the retaining wall is most likely not due to piping, but due to sediment removal and settlement over time (see Photo 9). Repeated ponding in the perimeter channel may eventually lead to seepage through any cracks. If this occurs on a regular basis, the following may result:

- (1) Piping of soils at the base of the soil cement retaining wall could occur, possibly compromising the structure (see Photo 9).
- (2) Though designed to handle the loadings of wetted soils, hydrostatic pressure build-up behind the retaining wall could lead to expansion cracking requiring maintenance.

Photo 9 – Soil settlement and erosion; Potential Piping at Base of Retaining Wall

- (1) Apply concrete grout to any cracks in flat areas. Advantages: Will promote evaporation and limit seepage. Low cost, hand application. Disadvantages: None.
- (2) Pressure grout Soil Loss areas at Base of Retaining Wall. Advantages: Address important maintenance item. Limit continued removal/sluffing of soil. Disadvantages: Mobilizing pressure grouting equipment. Cost of hiring pressure grouting specialist.

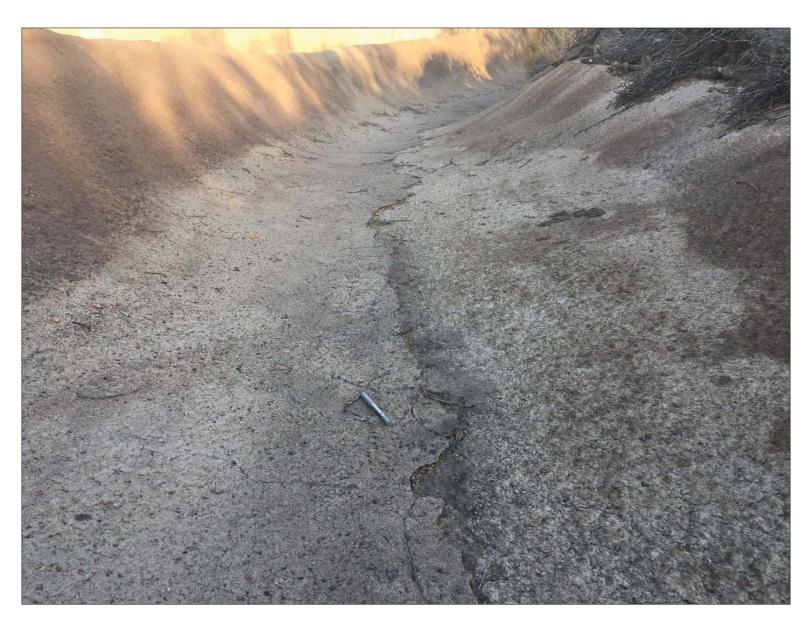
- (1) Flaking is occurring near Lots 38-40 (see Photo 10). Flaking is most likely occurring due to contraction/expansion separating a top layer of soil cement from another.
- (2) Parallel cracking is occurring in this same location (see Photo 10).

Photo 10 – Flaking and Parallel Cracking

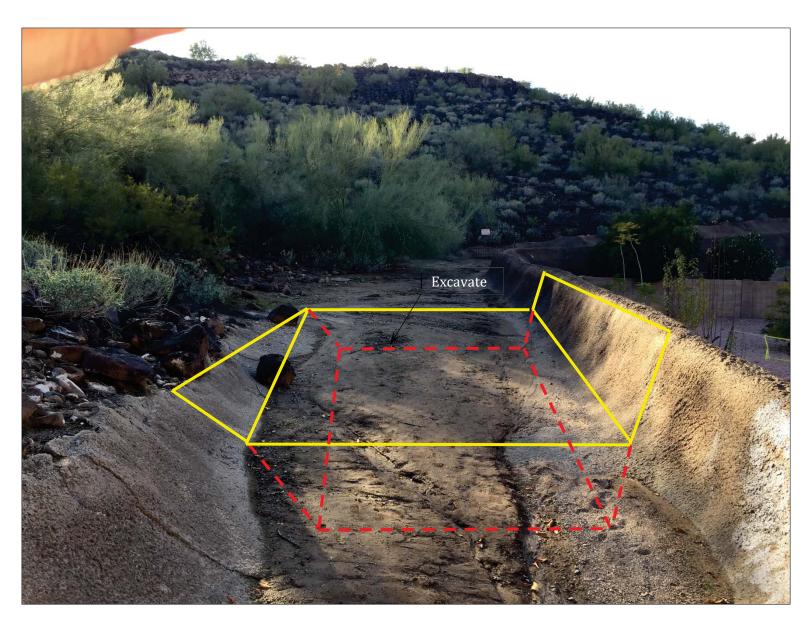
Photo 11 – Increase Sediment Capture from Catchment Area SB-6

Deepen the catchment area adjacent to the perimeter channel at the outlet of Sub-Area SB-6 (see Photo 11). Advantages: Would provide additional available volume for sediment capture. Would create a weir-flow condition into the concrete outfall channel thus producing cleaner water as sediment is trapped. Disadvantages: Construction would involve removal and replacement of a section of the soil cement channel. An outlet pipe through the depressed area leading to the outfall channel would be required to drain ponded water. Implementation would be relatively costly and care would need to be taken so as not to compromise the retaining wall during construction.

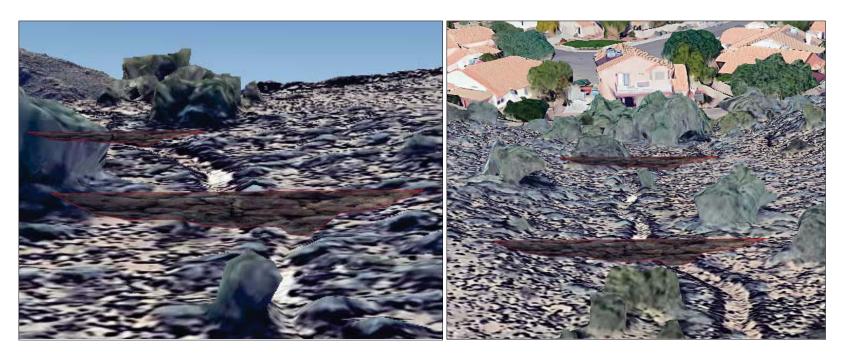
Photo 12 – Rock Check Berms along Washes

Install rock check berms on the hillside along the two primary stormwater accumulation areas (washes) within Sub-Areas SB-2 and SB-6 (see Photo 12 and Rock Berm Concept Detail). Advantages: Would provide additional available volume for sediment capture. Multiple check berms would intermittently reduce flow velocities and reduce the ability of the flows to carry sediment. Check berms can be constructed of rocks from the hillside, thus reducing costs. Disadvantages: Manual labor would be required to construct the berms, including hand selection of stones and placement of a compact matrix of stones). Maintenance and removal of sediment would occur on the hillside requiring hiking up the hillside.

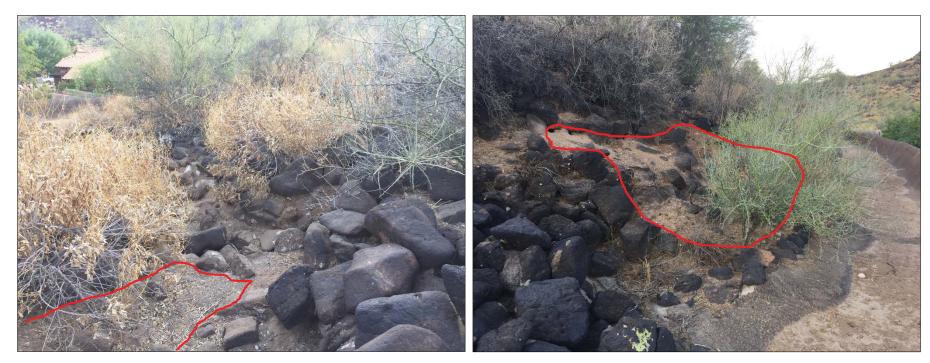
Photo 13 – Apply Soil Stabilizer to Exposed Areas

Apply spray-on soil stabilizer to areas of exposed soil contributing to sediment loading (see Photo 13). Advantages: Quite effective in reducing soil erosion. Relatively low cost. Mobile spray application and re-application by unskilled labor. Storage of extra product for future applications. Disadvantages: Reapplication after 2-4 years. Examples of stabilizer products listed below.

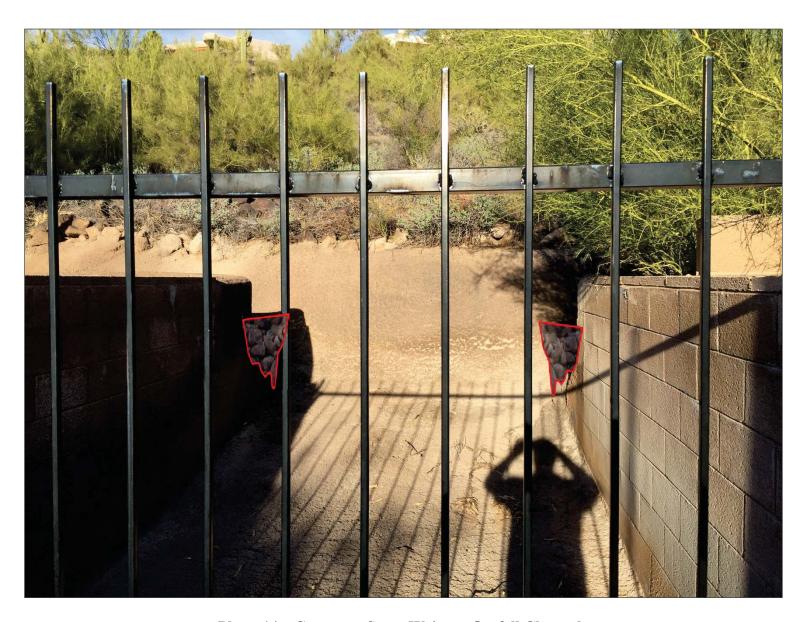
Photo 14 – Construct Stone Weirs at Outfall Channels

Construct small hand placed stone weirs near the outfall channels in the perimeter channel (see Photo 14). Advantages: Will trap some debris and sediment before flows enter the outfall channels. Low cost. Disadvantages: May lose stones. Will create additional areas to monitor for regular cleanout of sediment. May need to grout and provide small low-flow pipe (e.g. 4" pvc).
