# **Reserve Study Level I**

**Prepared for Meridian Firs No. 2's 2016 Fiscal Year**

Meridian Firs No. 2

Kent, WA

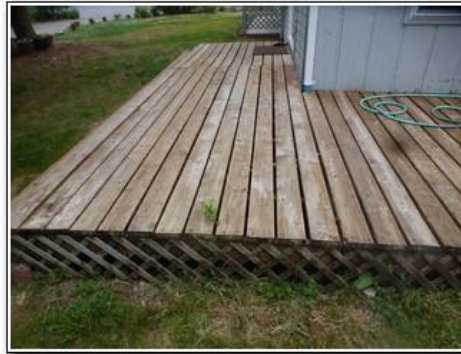
### Building Exterior - Deck, Wood: Replace

Reportedly the decks are Unit Owner responsibility so no Association funding is required. We recommend that the Association maintain oversight and establish standards to maintain community appearance.

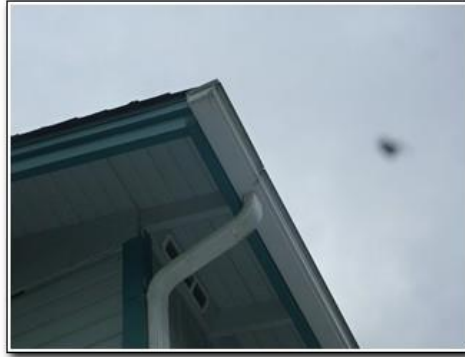
### Building Exterior - Gutters & Downspouts: Replacement (Phase 1)

Condition: Good

We understand there has been a multiyear project completing partial replacement of gutters. Prioritizing based on location and building needs. We have included an allowance to continue this pattern of replacement.

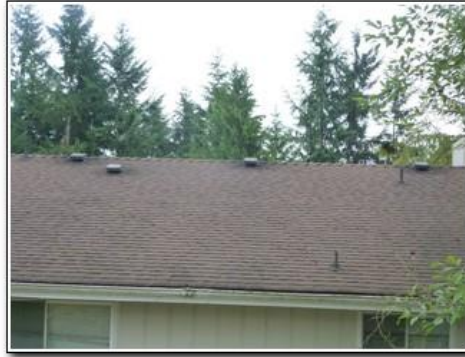
#### Building Exterior - Roof: Replace (Phase 1)

Condition: Good

Assorted condition of roofs based on location and repair history. Indications are that roofs were replaced last in approximately 2007. The typical life expectancy is between 20 - 25 years for this type of roofing. We recommend that the Association should have a professional roof inspection performed by an independent, qualified Roofing Inspector registered with RCI not a roofing contractor. Based on the condition of the roofs we recommend reducing the remaining life. Indications are that the roofs will not reach its full life expectancy (at least in select locations). Update as needed.

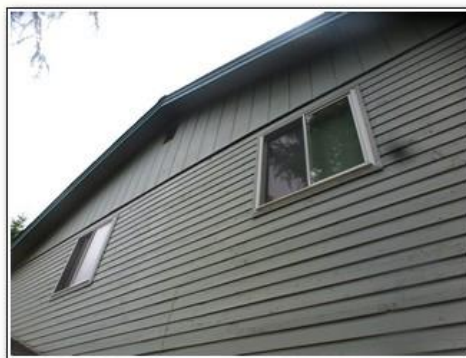
#### Building Exterior - Siding: Partial Repair/Replace

| Condition: | Assorted Condition | RUL: | 0 |

Generally fair condition with no known water intrusion or concerns. We strongly recommend regular inspections and repair to ensure the integrity of the building envelope. Reserve funding recommended for partial replacement with each repainting cycle, include chimney chases and caps within this allowance as well. Should patterns of repair arise, additional funding may be included in future reserve studies. Because painting is scheduled to be completed on an annual basis, we have included funding for repairs annually as well.

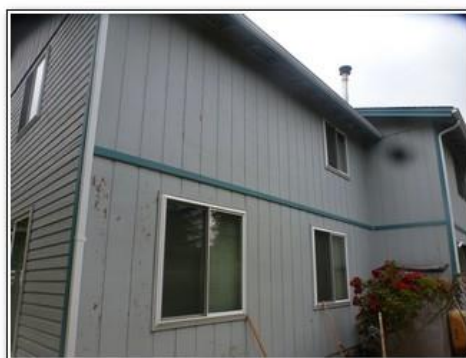
#### Building Exterior - Siding: Repaint

| Condition: | Assorted Condition | RUL: | 0 |

The Association's past practice has been to paint 1-2 buildings per year. Under this pattern of paint management the condition is varied at this time. Regular paint cycles are important to maintaining and protecting the siding. Inspect regularly touch up paint and caulking as needed from the operating budget. To optimize the painting costs, we recommend that a professional painting and/or coating inspector be retained to inspect the existing paint film thickness and adhesion. A painting inspector can also prepare a written specification which would ensure that selected painting contractors are all quoting on the same products and methods of painting. The painting inspector can also perform wet film tests while the painting is being done to ensure that the correct amount of paint is being applied. The painting costs can be further optimized by repainting those wall elevations that receive the most weathering from sun and rain are repainted frequently enough. Similarly, those elevations, such as north facing walls, that do not require repainting as frequently the repainting cycle can be extended.

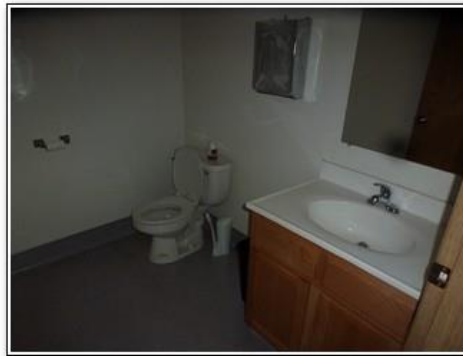
#### Building Interior - Cabana Interior: Refurbish

| Condition: | Fair | RUL: | 4 |

We have included a modest allowance to update the interior of the cabana every 5 years. Therefore, every 5 years the different aspects of the interior may be refurbished, including the bathrooms, flooring, painting, kitchenette cabinets and fixtures.

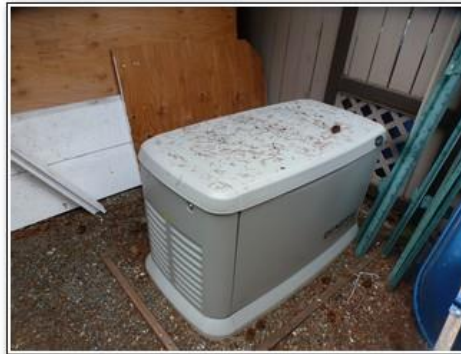
Condition: Good  
 Funding Basis: Funded based on the typical life expectancy

This 20 KW generator powers the cabana in the event of a power outage. We recommend following the manufacturers recommendations for maintenance and weekly/monthly start up and routine running and testing.

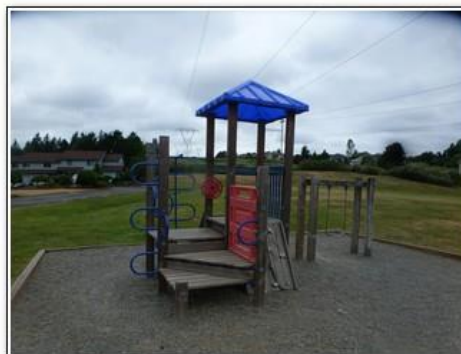
Condition: Good

Good condition with no structural instability or unusual deterioration noted during our inspection. Inspect regularly and refurbish fall zones and repair as needed utilizing the operating budget. Reserve funding recommended.

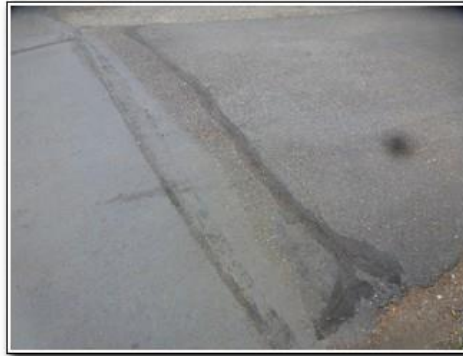
#### Site/Grounds - Asphalt Patching

| Condition: | Good | RUL: | 5 |

Patching last performed in 2015. **Best to be done on a 5 year cycle timed with other asphalt sealing.**

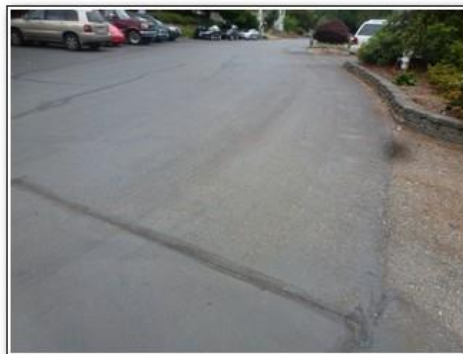
#### Site/Grounds - Asphalt: Resurface

| Condition: | Good | RUL: | 12 |

Good condition of asphalt, with no unusual cracking, waviness or deterioration noted. Most asphalt areas can be expected to last approximately 25 to 30 years before it will become necessary for an overlay to be applied. The Association's road are now 33 years old but a patching program will extend the time before an overlay will be required. It will be necessary to adjust manhole and valve covers at the time the overlay is applied. As routine maintenance ensure that drains and grates are free of debris and properly functioning. We recommend regular cycles of seal coat.

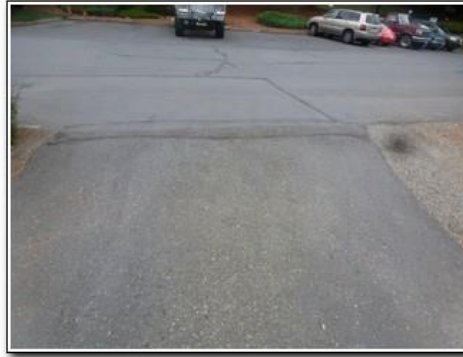
#### Site/Grounds - Asphalt: Seal

| Condition: | Poor | RUL: | 0 |

Generally poor condition of asphalt surface with some localized areas that are dry and faded. We recommend regular seal cycles be completed to maximize the life of asphalt. Seal coat and crack filler protects against damaging elements, such as oil, water, UV, etc. As routine maintenance ensure that oil spills are promptly cleaned and drains and grates are free of debris and properly functioning. Reserve funding recommended for regular cycles of seal coat and local areas of repair every 5 years.

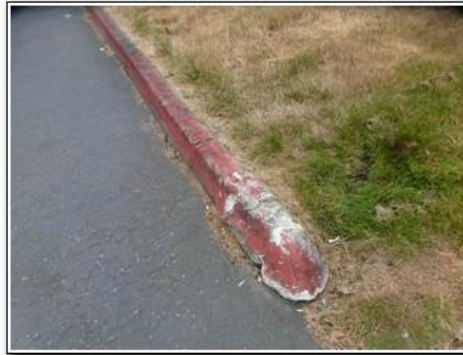
#### **Site/Grounds - Concrete Curb**

Fair condition with some deterioration noted. Inspect and pressure wash annually and repair as needed from the Operating budget.

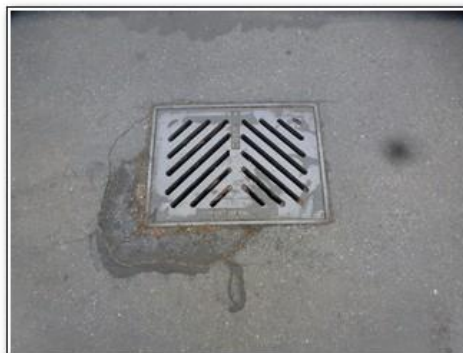
#### **Site/Grounds - Drainage & Storm Drainage**

Local areas of drainage concerns reported, however, at this time, there is no predictable expectation of large project expenses. At this time, no funding is suggested, update as needed.

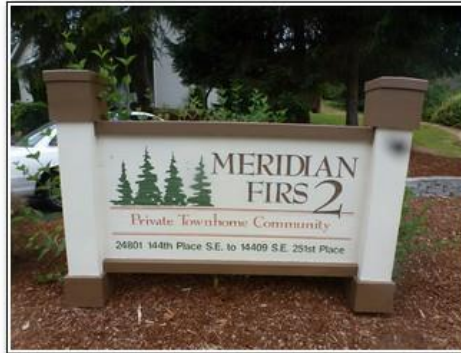
#### Site/Grounds - Entry Sign: Refurbish

| Condition: | Good | RUL: | 5 |

Good condition of wood signs. These units need to be painted regularly to maximize the life expectancy. Reserve funding recommended.

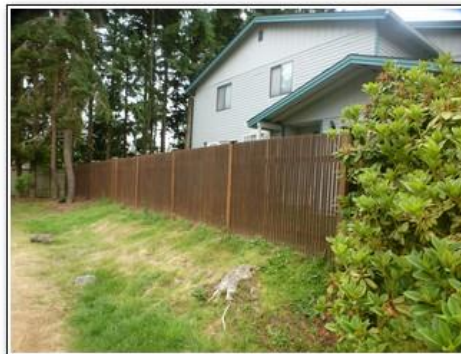
#### Site/Grounds - Fence: Wood/Chain Link, Replace

Reportedly this is the responsibility of the unit owners and/or adjacent property owners, therefore, no Association funding required.

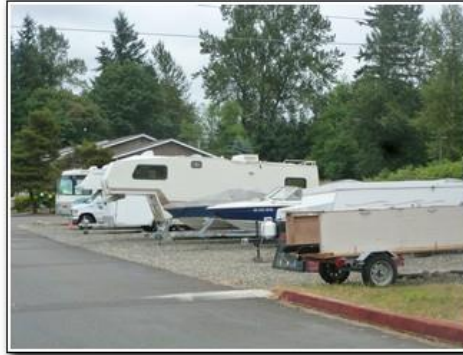
#### Site/Grounds - Gravel R.V. Parking: Refurbish

Various conditions noted. We suggest including the gravel areas within the landscape contract to provide proactive maintenance. Refurbish rock as needed on an annual basis. No reserve funding suggested.

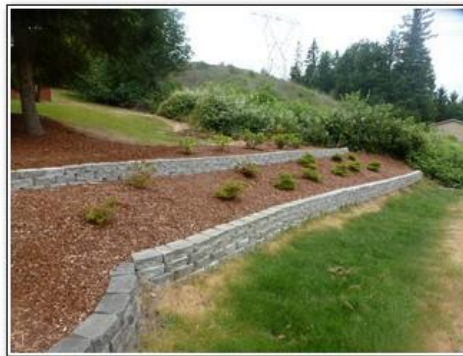
#### Site/Grounds - Landscaping: Refurbish

This component may be used to fund large landscape projects not budgeted within the operating funds. We understand there is no desire to fund this within reserves at this time. Therefore, no reserve funding.

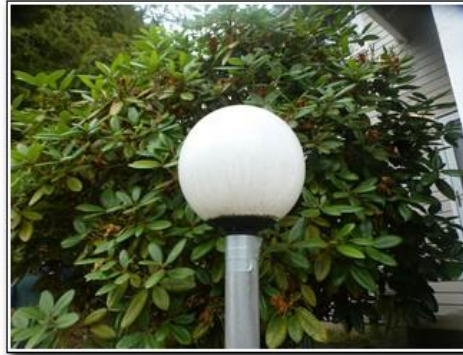
#### Site/Grounds - Lights: Pole, Replace

Condition: Fair

Dated condition with ongoing repair completed utilizing the operating budget. Reportedly the lights adjacent to the Units are Unit Owners responsibility; therefore we reduced the quantity and only funded lights adjacent to common areas.

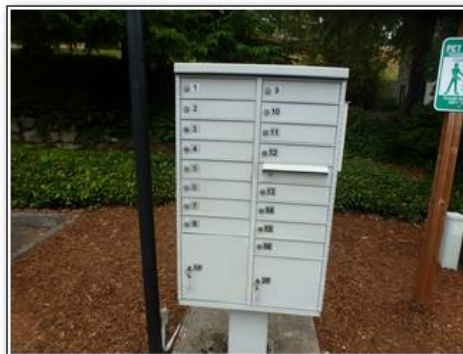
#### Site/Grounds - Mailbox Cluster: Replace

| Condition: | Good | RUL: | 13 |

Good condition of mailboxes with no unusual damage observed. Clean as needed to maintain appearance. We suggest planning for eventual replacement of the mailboxes to ensure functionality and community aesthetics.

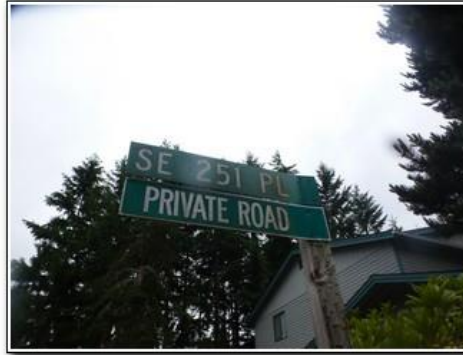
#### Site/Grounds - Signs: Replace

Fair condition with no damage or concerns at this time. We understand there is no expectation to replace at one time, therefore, no reserve funding. Treat as a maintenance item.

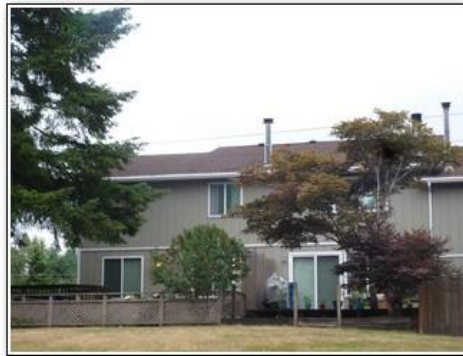
#### Site/Grounds - Trees: Trimming

We have not included an allowance for periodic tree trimming not included in the regular landscaping work. Include in future Reserve Study updates if directed by the Board.
