COMMERCIAL WINDSTORM MITIGATION REPORT

Scopello Condominium Association, Inc.

COMMERCIAL WINDSTORM MITIGATION REPORT (OIR-B1-1802)

2200 Gulf Blvd, Units 201-406

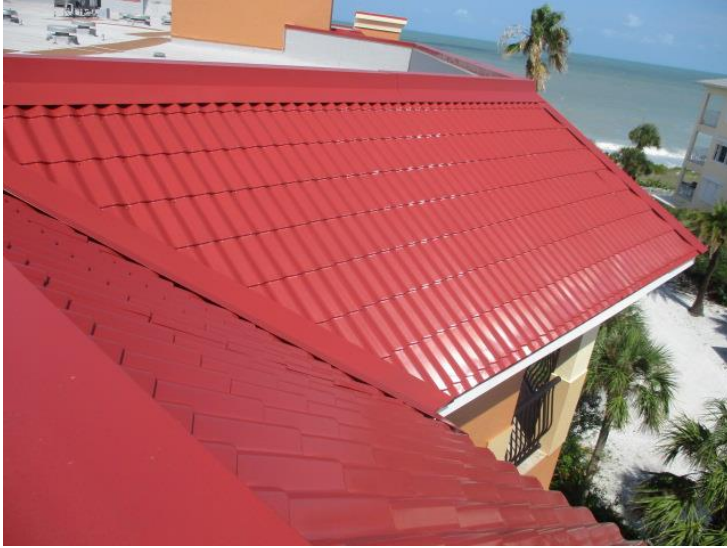
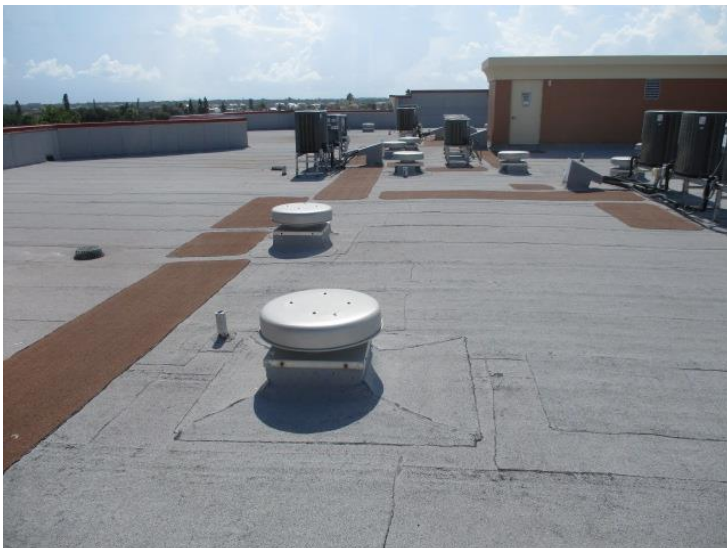
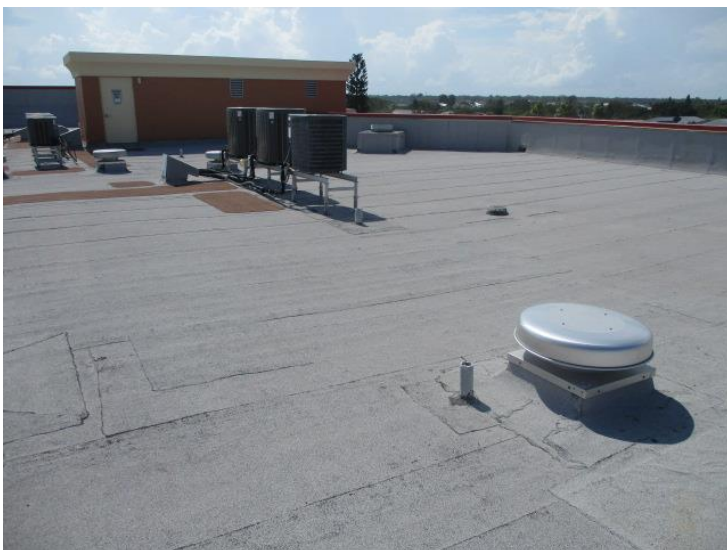
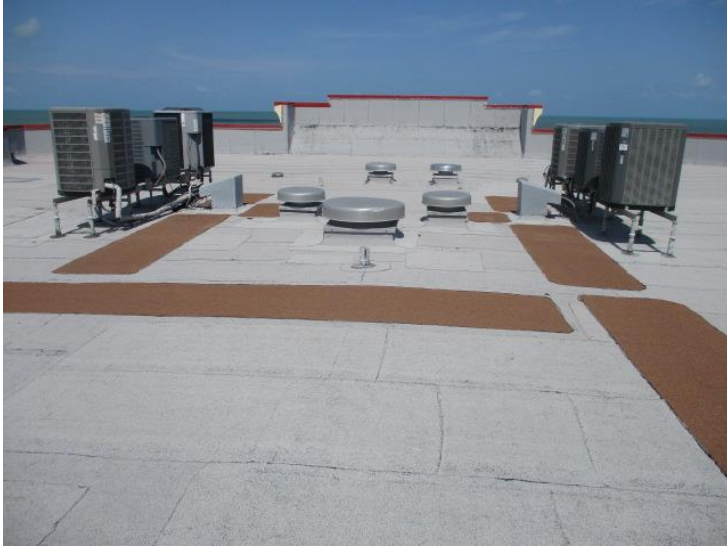
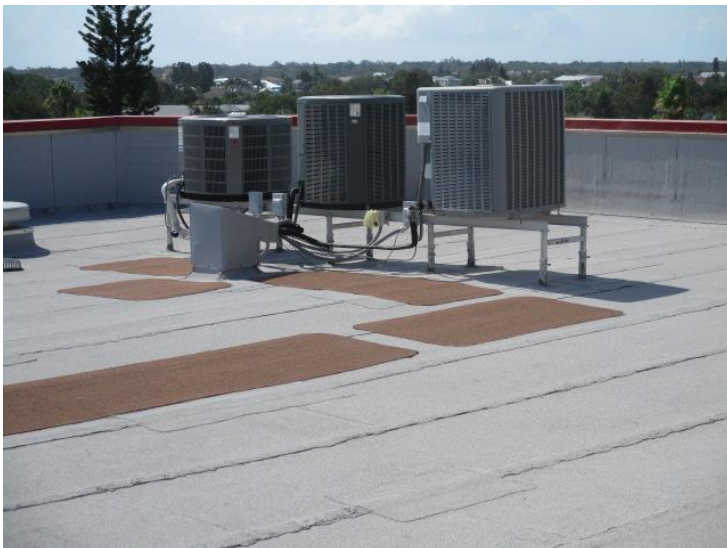
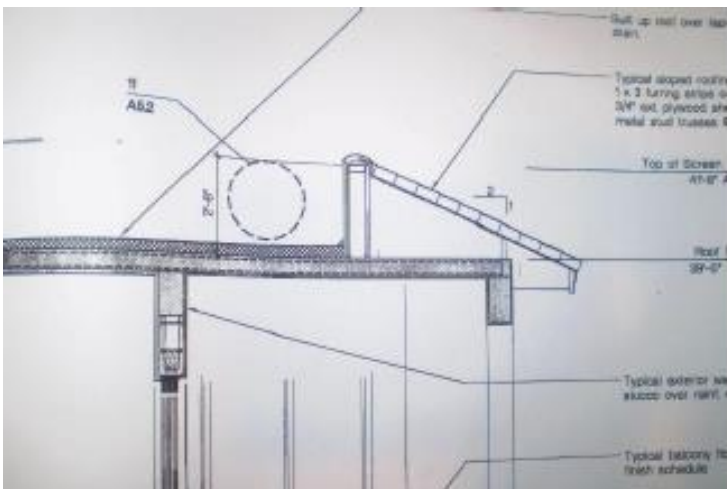
Roof Construction

| 3. <u>Roof Deck Attachment:</u> Comments: | Reinforced Concrete Roof Deck Inspection verified 6" hollow core concrete roof deck. |
| 4. <u>Roof to Wall Attachment:</u> Comments: | Structural Inspection verified a roof structure composed of cast-in-place or pre-cast structural concrete designed to be self-supporting and integrally attached to the wall / support system. |
| 5. <u>Roof Geometry:</u> Comments: | Flat Roof Inspection verified flat roof shape, refer to attached photographs. |
| 6. <u>SWR:</u> Comments: | No SWR does not apply to reinforced concrete roof decks. |

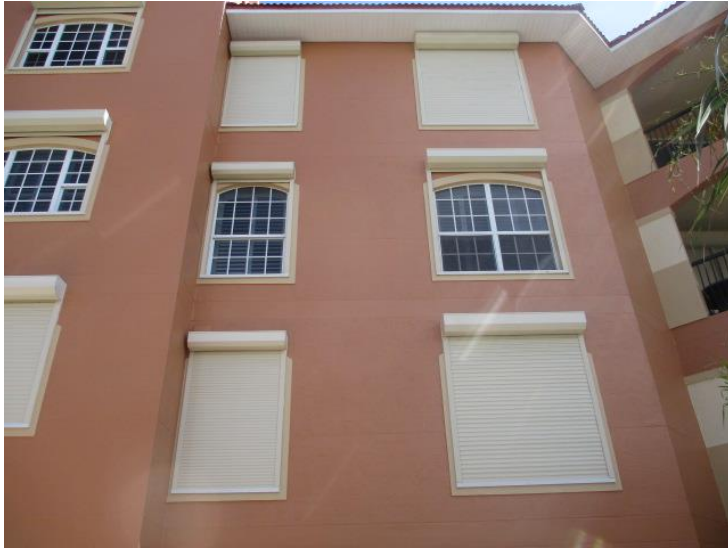
Opening Protection

| 7. <u>Opening Protection:</u> Comments: | None or Some Glazed Openings Inspection verified some metal shutter opening protection. Not all glazed openings were protected with impact resistant coverings. |

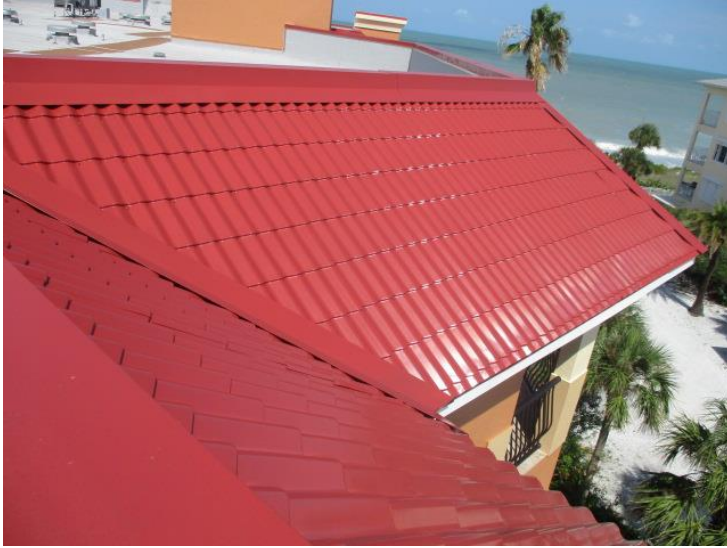
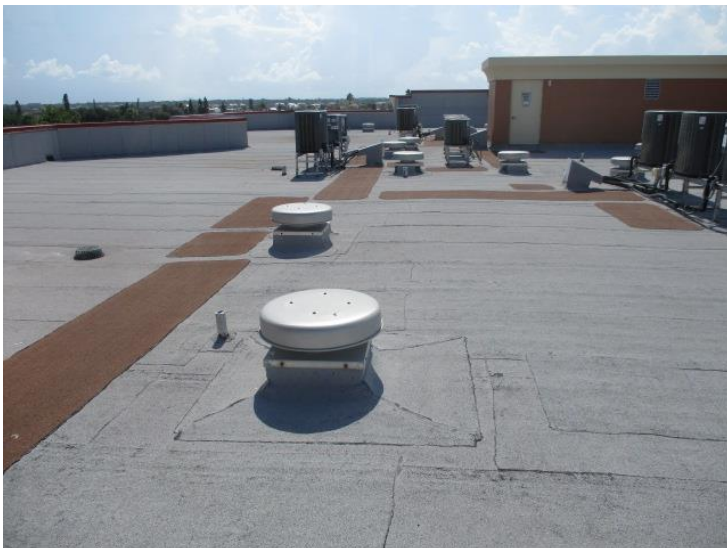
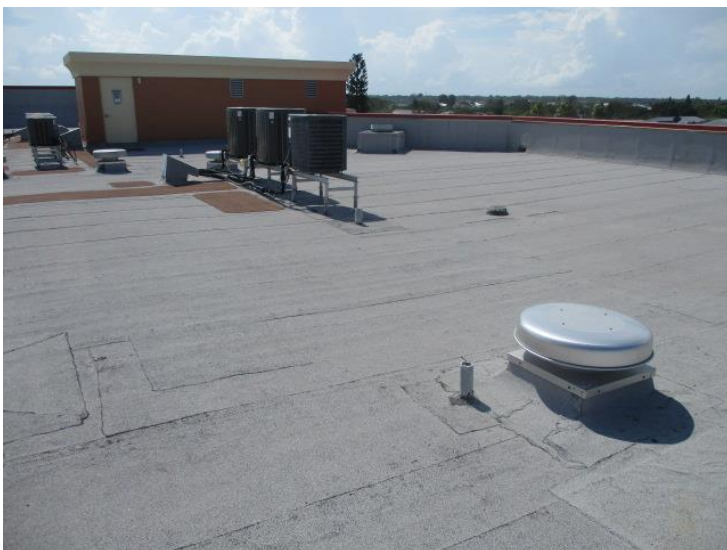
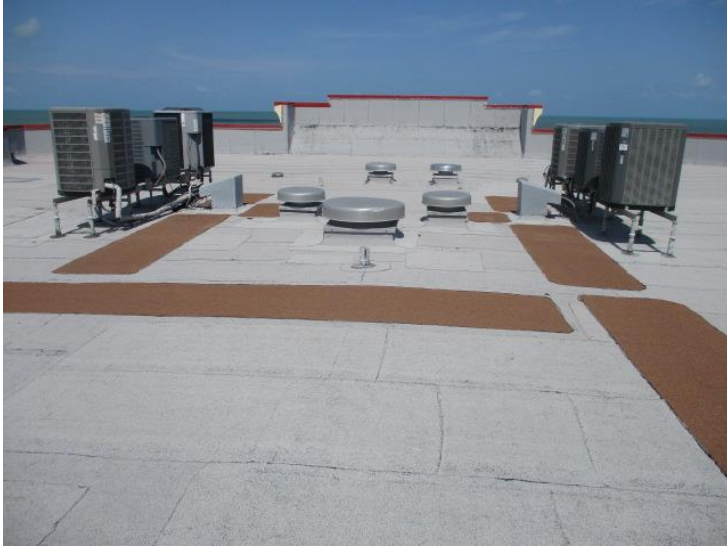
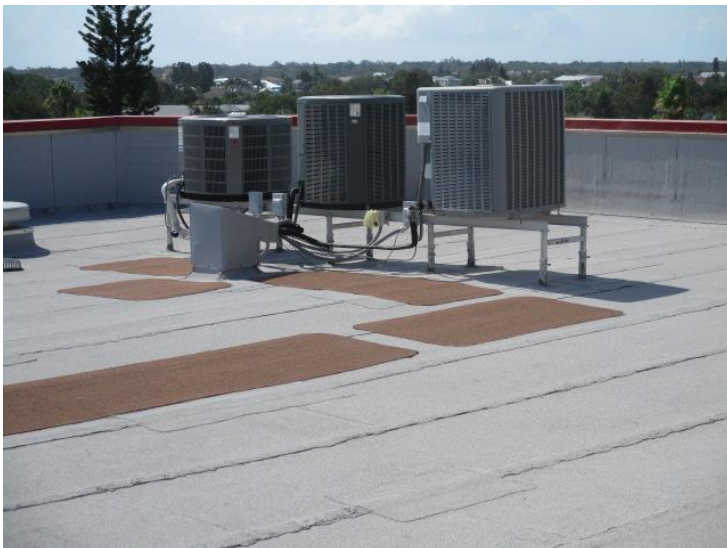
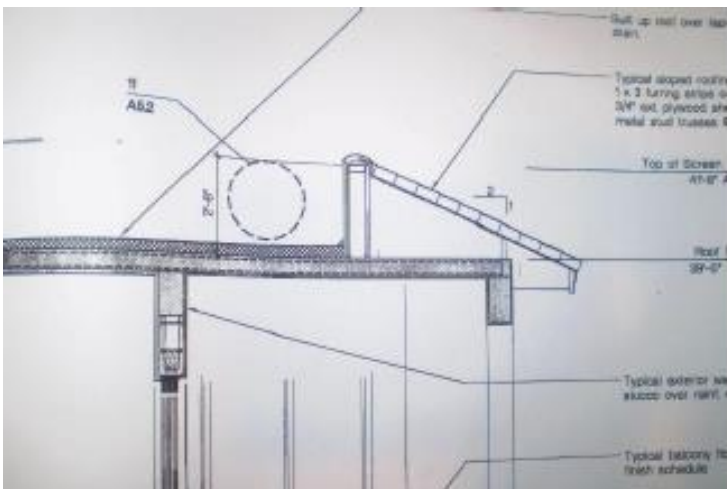
Roof Construction

| 2. <u>Roof Deck Attachment:</u> Comments: | Reinforced Concrete Roof Deck Inspection verified 6" hollow core concrete roof deck. |
| 3. <u>SWR:</u> Comments: | No SWR does not apply to reinforced concrete roof decks. |

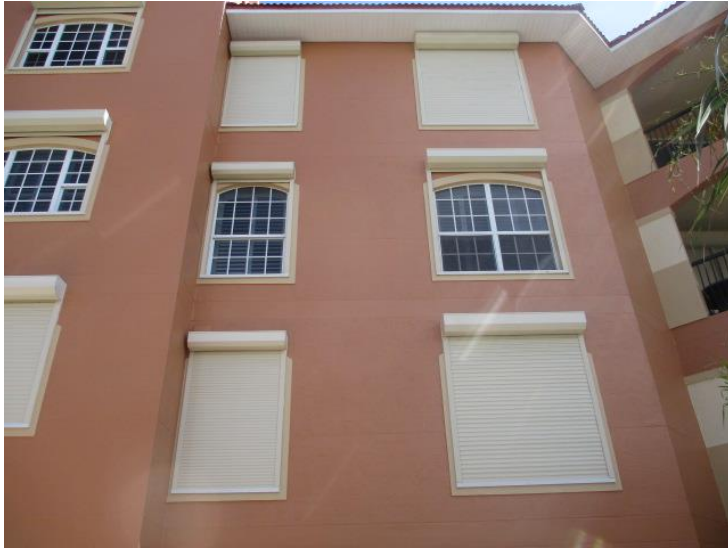
Opening Protection

| 4. <u>Opening Protection:</u> Comments: | None or Some Glazed Openings Inspection verified some metal shutter opening protection. Not all glazed openings were protected with impact resistant coverings. |
