Client: 15449A Meridian Firs 2

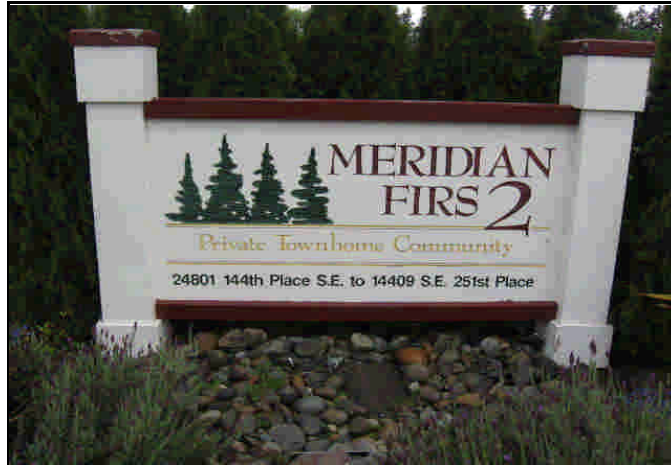
Evaluation: Per the direction of the Board, we have factored the estimated cost for reserve study update with site inspection, to occur every three years to assess current physical and economic conditions impacting the long term reserve plan.
