Re: Reserve Analysis, 2013 VERSION

for the Stanton Farms Townhouse Association, Inc., located in Littleton, Colorado As requested, Bradley Property Consultants, Inc. revised and updated the 2010 reserve analysis

CHANGES AND COMMENTS FOR THE 2013 UPDATE AND REVISION

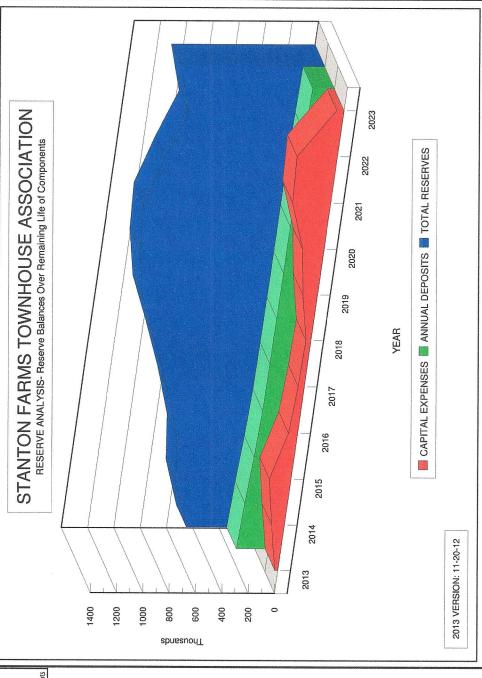
NO CHANGE	HAND TEAH		4330,000	>	ALUE OF RES	ERVE ITEMS		\$2,072,218	
	۵	ENDING BALANCE YEAR 11	CE YEAR 11		\$1,092,227	A	/ERAGE CAP	AVERAGE CAPITAL EXPENSE	ш	\$125,155	
	A	/ERAGE BAL/	NCE		\$956,790	A	/ERAGE DEP	DSIT		\$194.449	
	-	N	က	4	rc	œ	7	oc	σ	Ç	+
YEAR	2013	2014	2015	2016	2017	2018	2019	2020	2004	2000	- 0000
CAPITAL EXPENSES	(22,800)	(98.800)	(165.016)	(71.216)	(47.904)	(38 000)	(112,875)	(163.816)	(703 056)	(300,000)	202
ANNUAL DEPOSITS	240.964	228,321	208.082	192.962	188.618	186.564	185 757	184 191	184 101	174 377	164 007
TOTAL RESERVES	548,164	677,685	720,752	842,498	983.211	1.131.776	1.204.658	1.225.033	1,116,167	982.520	1 092 227

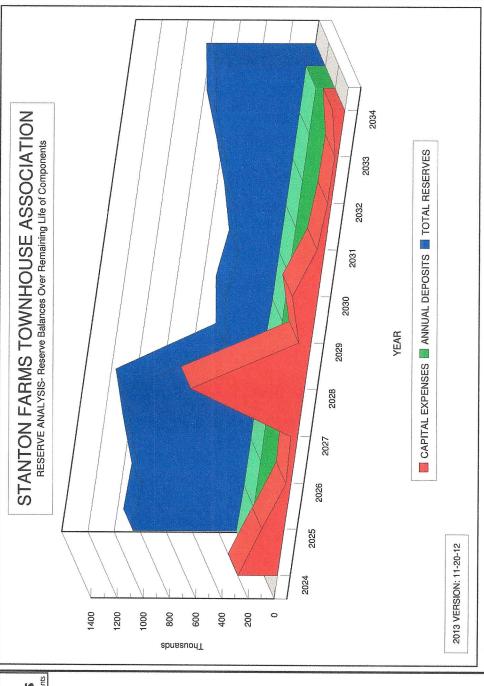
2000	THE RESERVE THE PROPERTY OF TH	STREET, STREET	Secretary of the second	The state of the same of the same of the state of the same of the	A STATE OF THE PARTY OF THE PAR					
	æ	SERVES ON	HAND YEAR 1	2	\$1,225,033	*	ILUE OF RESE	RVE ITEMS	93	32,072,218	
	الم	IDING BALAN	3 BALANCE YEAR 22		\$832,918	A	AVERAGE CAPITAL EXPENSE	FAL EXPENSE		\$175,546	
	A	VERAGE BALANCE	ANCE		\$758,864	AV	ERAGE DEPC	SIT		\$151 973	
MODERN AND ALCOHOLOGIC CONTRACTOR AND ALCOHOLOGIC CONTRACTOR CONTR	12	13	4	5		17	18	10	20	2	66
YEAR	2024	2025	2026	2027		2029	2030	2031	2032	2033	73 06
CAPITAL EXPENSES	(302,918)	(171,016)	(38.816)	(52.800)	-	(94.000)	(196 216)	(59.216)	(30 000)	(77 800)	1000 00/
ANNUAL DEPOSITS	164,907	158,186	158.186	158.186	157.862	145,729	145 720	145 720	145 770	145 720	145 720
TOTAL RESERVES	954.216	941.386	1.060.755	1.166.141		505 307	454 820	541 339	687 061	77.0 000	143,147
	And the second name of the secon	7		white or the same		100000	OWO TO	Con A second		117.7.71	0.00

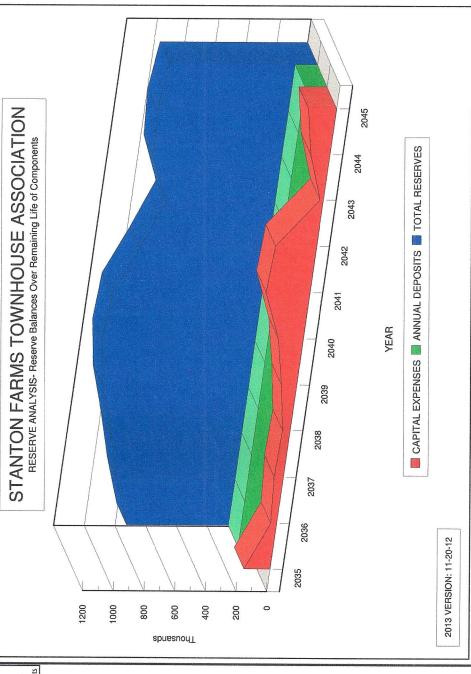
2	SERVES ON	RESERVES ON HAND YEAR 23	23	\$541,332	8	LUE OF RES	ERVE ITEMS		\$2,072,218	
		IDING BALAN	ICE YEAR 33		\$961,669	AV	'ERAGE CAPI	AVERAGE CAPITAL EXPENSE		\$134,024	
	A	ERAGE BAL	ANCE		\$987,488	AV	ERAGE DEP	SIT		\$145.729	
	23	24	25	56			66	30	24	32	23
N.F. A.D.	L			1 1)	3	5	100	3
והאחר	2035	2036	2037	2038			2041	2042	2043	2044	2045
CAPITAL EXPENSES	(169,816)	(40,016)	(59,904)	(51,200)	8	ı	(287.056)	(269.040)	(24.000)	(125,200)	(184 216)
ANNUAL DEPOSITS	145,729	145,729	145,729	145.729	145.729	145.729	145,729	145,729	145 720	145 720	145.720
TOTAL RESERVES	808,831	914.543	1.000,368	1.094.897	1		981 210	847 800	070 627	1 000 156	061 660

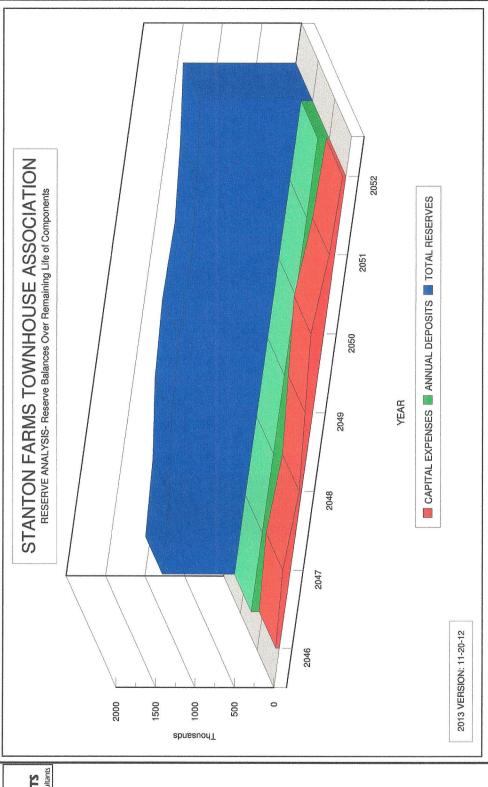
0	ECEDVEC ON	UAND VEAD	70	\$0E7 000	>	מומים מים וויי	
		ESERVES ON	ESERVES ON HAND TEAN SA	***	860'/CO&	>	VALUE OF ARGERVE II RING	
	Ш	NDING BALANCE YEAR 0	NCE YEAR 0		\$0	A	VERAGE CAPI	AVERAGE CAPITAL EXPENSE
	A	AVERAGE BALANCE	ANCE		\$1,240,084	A	AVERAGE DEPOSIT	TISC
	34	35	36	37	38	39	40	
YEAR	2046	2047	2048	2049	2050	2051	2052	
CAPITAL EXPENSES	(46,016)	(96,584)	(30,800)	(98,800)	(165,016)	(71,216)	(43,200)	
INNUAL DEPOSITS	145,729	145,729	145,729	145,729	145,729	145,729	145,729	
TOTAL RESERVES	1,061,381	1,110,526	1,225,454	1,272,383	1,253,096	1,327,608	1,430,137
