# RTC-TH Dec 2013 Update 2

Community-based environmental education for the self-sufficiency and sustainability of small rural family farms

## Our Rice Harvest in Perspective

## ***Nam Yang River Make-Over***

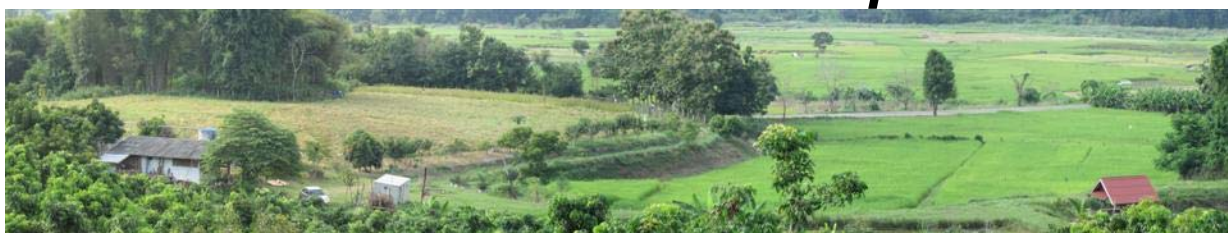
Rice on our farm: Dry upland rice (large yellow field to left) and wet paddy rice (large green fields to right).

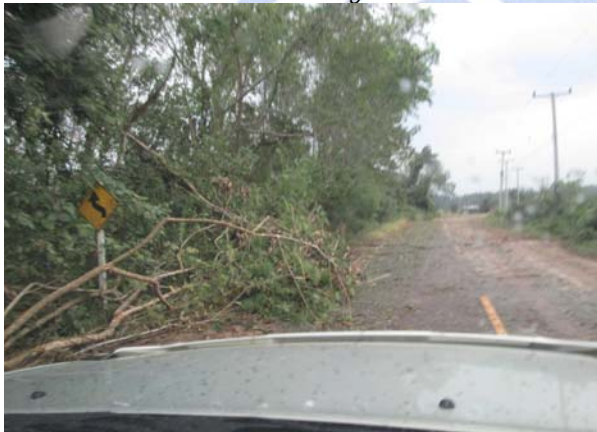
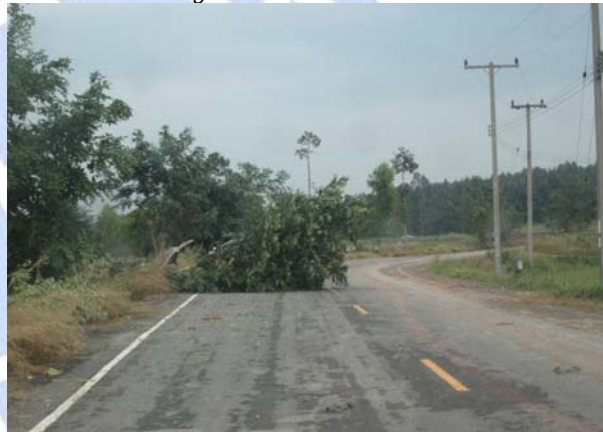
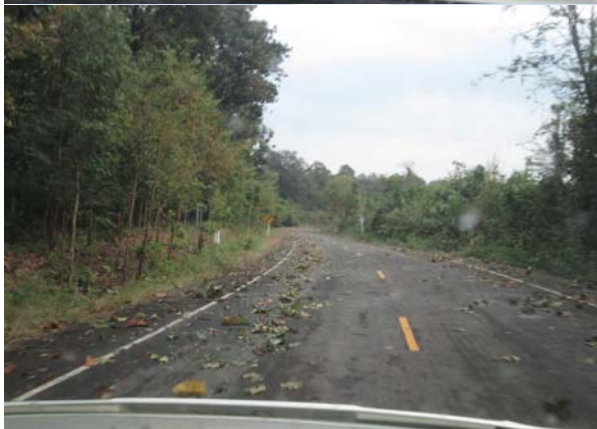
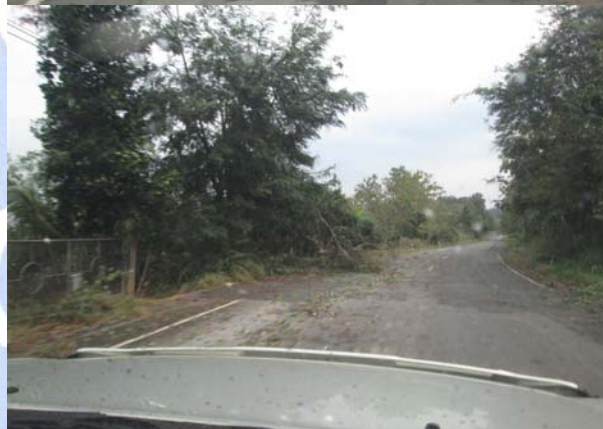
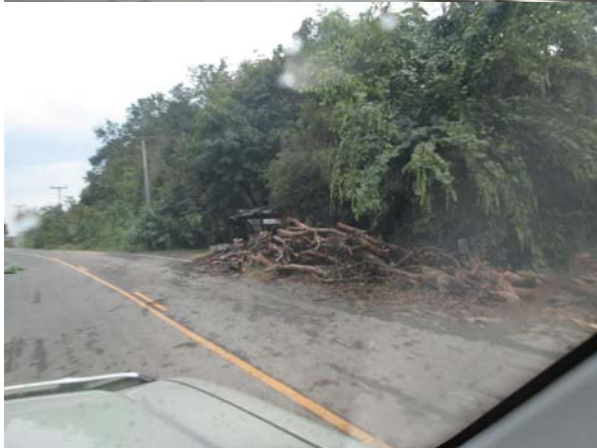
Driving to and from the village to town started off fairly normal. At Ban Yu, the first evidence of storm damage appeared. From that point on, leaves, debris and fallen trees became more frequent. We didn't see any government crews clearing the streets. Utility workers handled power line problems. Local residents all seemed to clear any fallen trees associated with their property. Schools called in workers to clean up major problems. 🌐

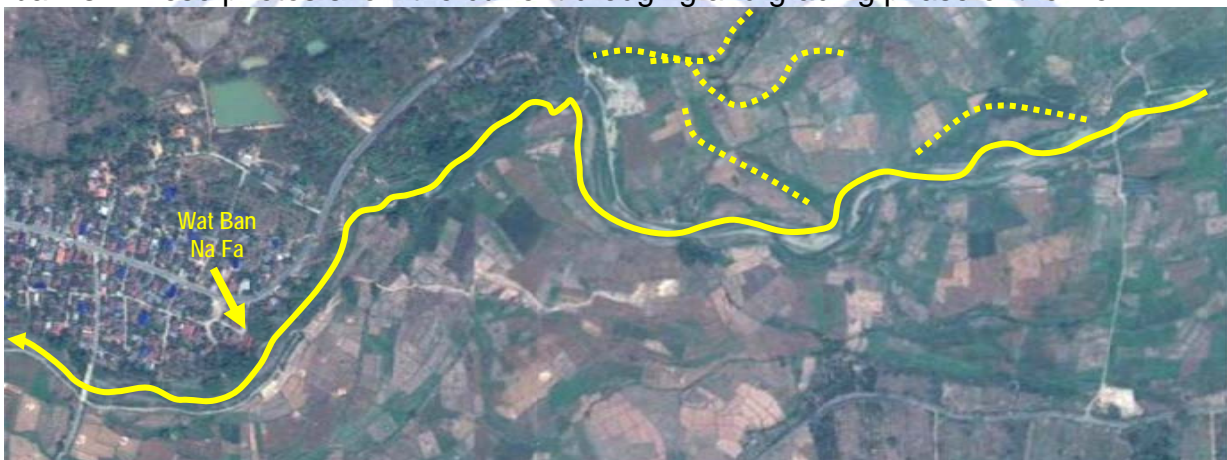
*The curving / twisting Nam Yang river bed attests to the low slope gradient of the floodplain (yellow solid line). This satellite view reveals some possible "meander scars" of past river bed alignments (yellow dashed line).*

The Nam Yang River floods annually during the wet monsoon rainy season (May-Oct). The average slope of the Nam Yang floodplain from near Sila Phet waterfall to the bridge at Ban Na Fa is about 1%. This is a fairly flat flood plain. A river flowing on this flood plain tends to meander (swing back and forth rather than flowing in a fairly straight line). The changes in river bed alignment are part of a dynamic natural process. However, losses of property and changes of boundaries prompt officials to control the alignment of the river. Wat Ban Na Fa (our village temple) is threatened with destruction by erosion. Both the north and south bridge abutments at Ban Na Fa over the Nam Yang have been under severe attack for the last few years.

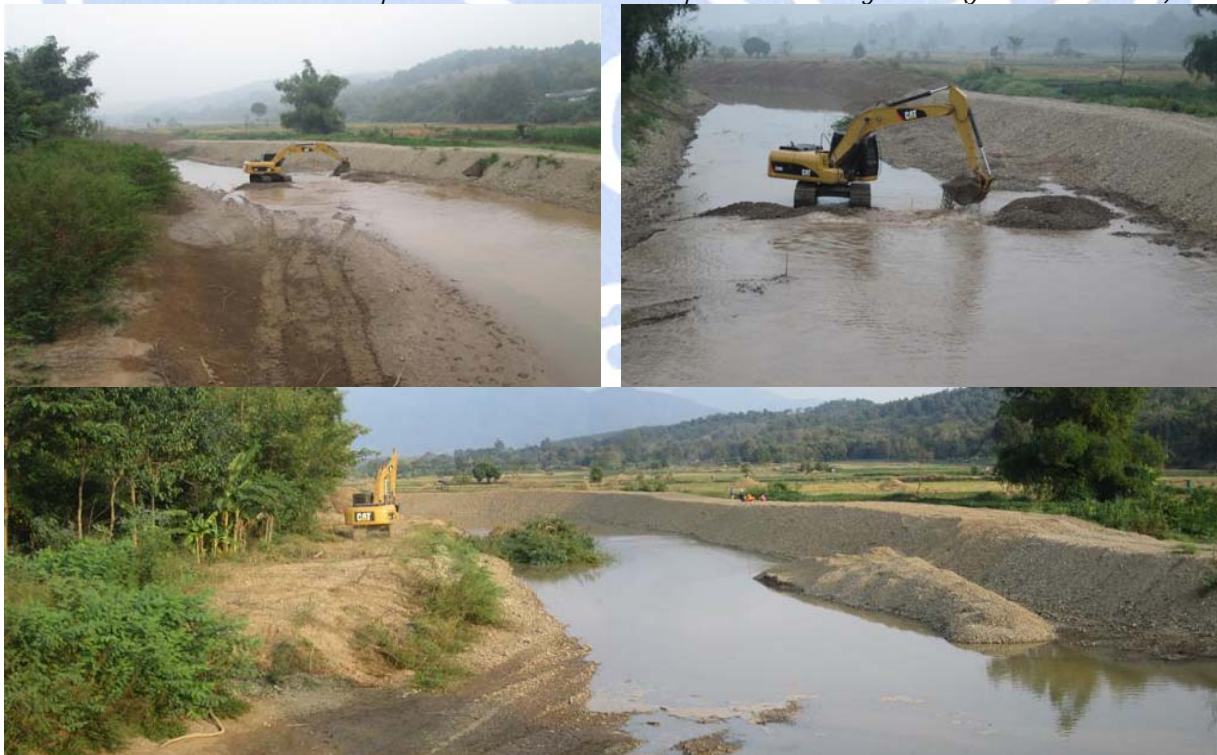
This month, a major erosion management project commenced for a stretch of the Nam Yang in the Ban Na Fa area. They are dredging and re-grading the banks of the river. Riprap of rocks encaged in steel mesh will be installed to protect the soil banks. These photos show the current dredging and grading phase of the work.

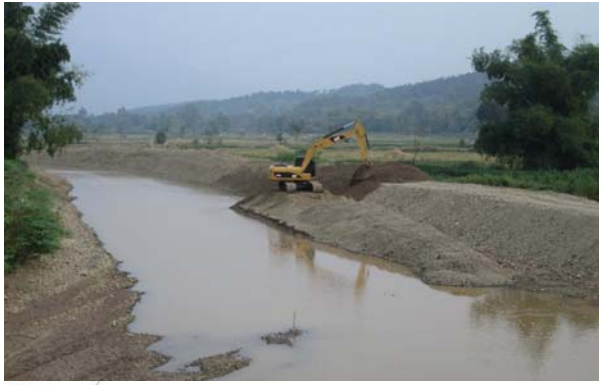
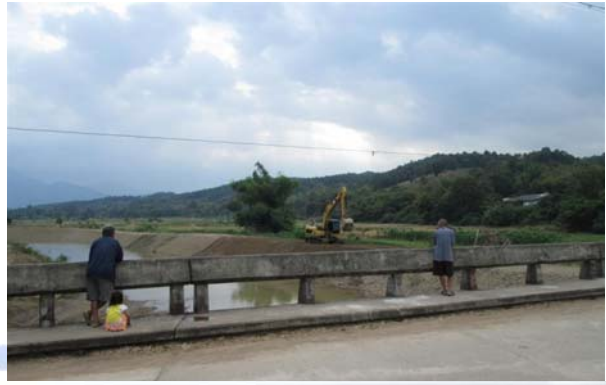
The new levee seems to be higher on the north bank (our side of the river) than the south. The added protection of the riprap will alleviate our concerns for erosion on the south boundary of our property in the village.

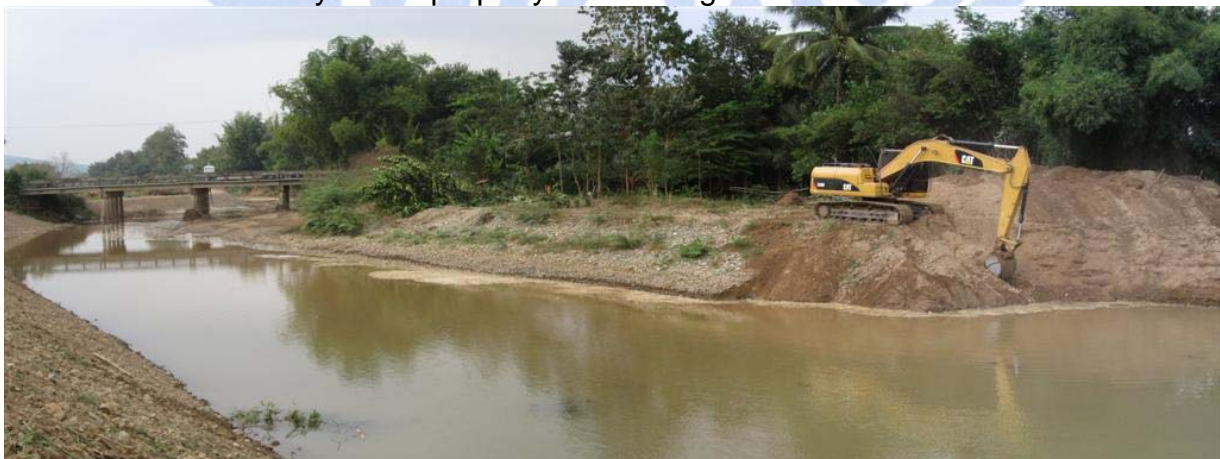
A work crew began installing the riprap just upstream from Wat Ban Na Fa (our village temple). Riprap is a layer of rock “armor” to protect the levee from erosion. They diverted the river around the work site to get clean access to the river bed. They laid out a white geo-textile layer. A series of wire cages are set in place at the levee base. These filled with rocks. A wire mesh array is secure to the base level cages, then rolled up the levee face. It consists of 6 parallel “fences” extending across the slope. Each row is secured by bamboo stakes into the levee, and bamboo poles to support the upper edge of the fence. Cobbles are dumped into each row filling it to a depth of about 30 cm. Then a wire mesh cover is placed over the top to lock everything into place.

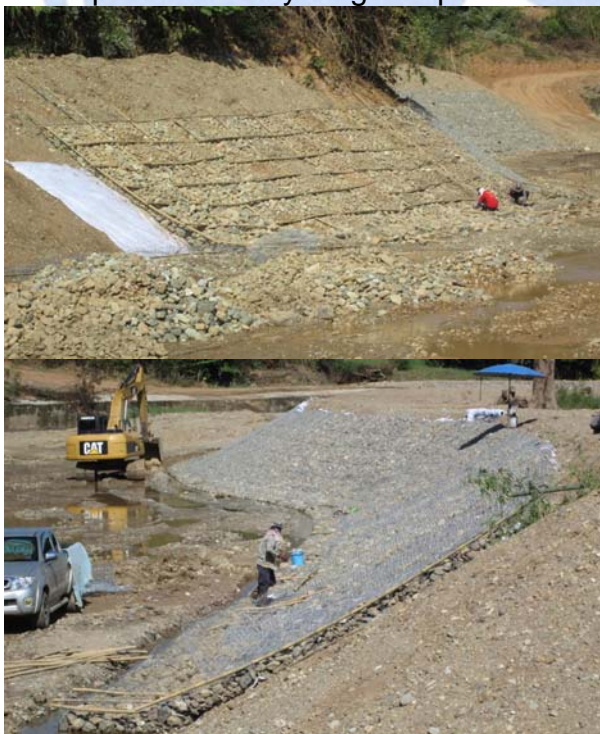
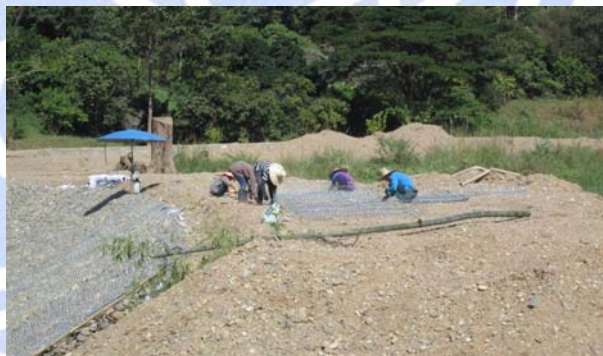
The system relies on mass and gravity to keep the riprap in place. The photo on the left gives a cross-section view of the rock layer and wire mesh. The rock-filled wire cages (yellow arrow) anchors the system to the river bed. The depth of the riprap is thicker at the base and tapers toward the top of the levee. We have to wait and see how they handle the riprap for the bridge abutment near our house.

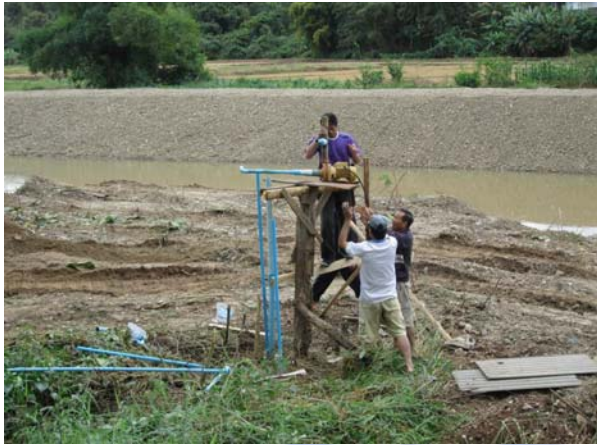
A notice to our neighbors said their wells along the Nam Yang would be buried by the new levee. They opted to keep the wells in place, but to raise the pumps to conform to the new levee height.

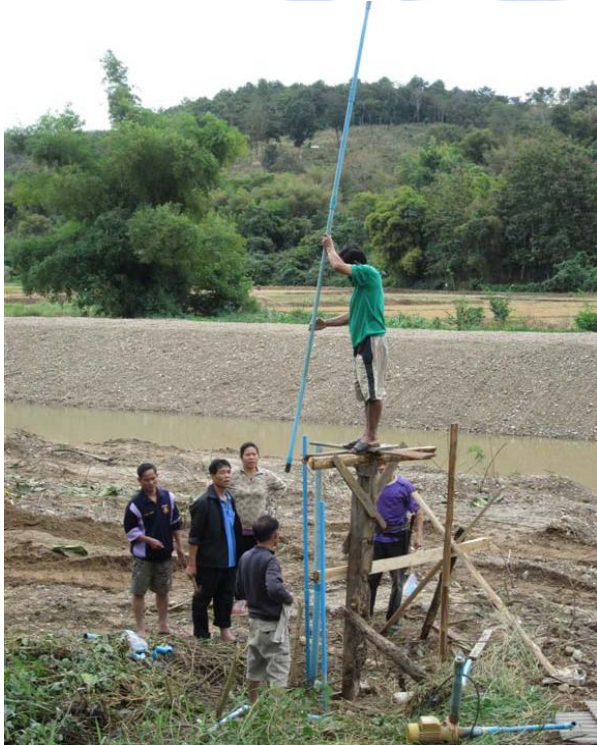
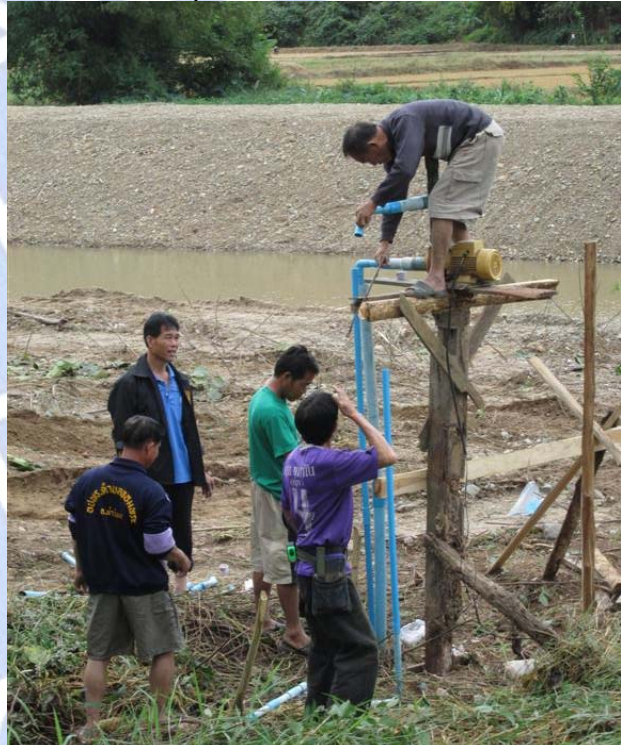
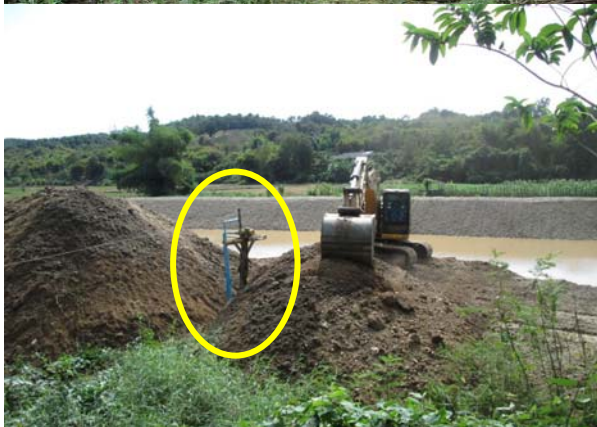
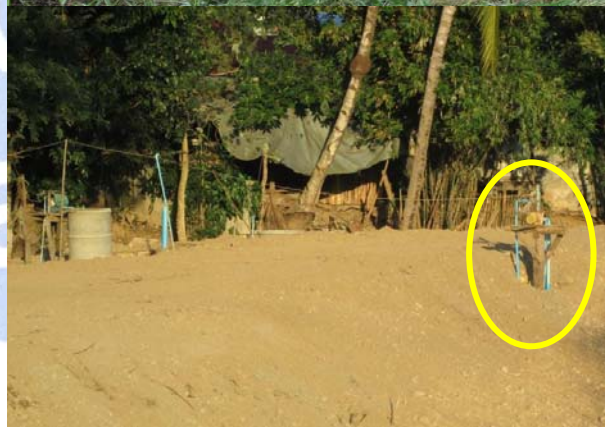
*The elevated well-head and its new appearance in the newly graded levee (yellow circle in photos above).*
